# **Inspection Report**

# Sample Report

Property Address: 1234 Sample Blvd Sampletown MN

## Solid Foundations Home Inspections

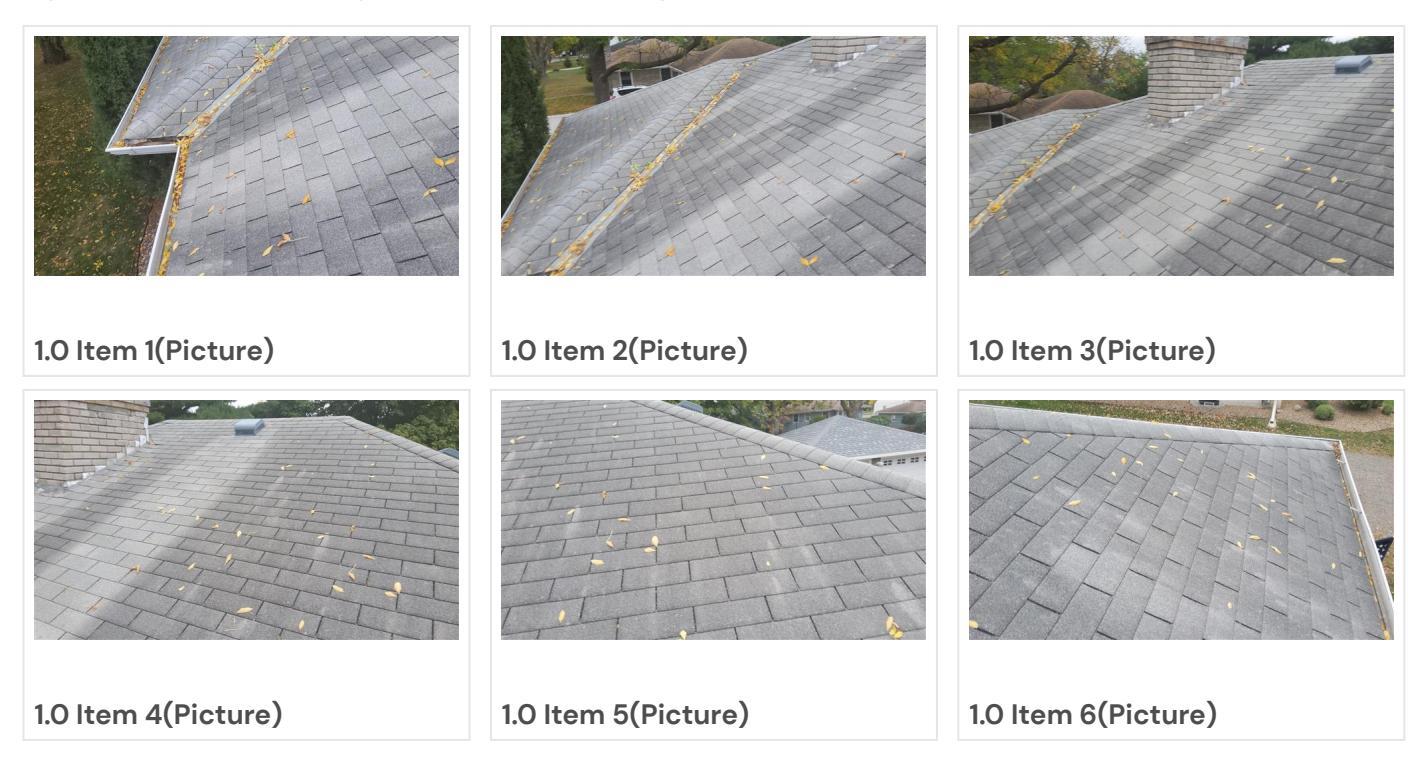
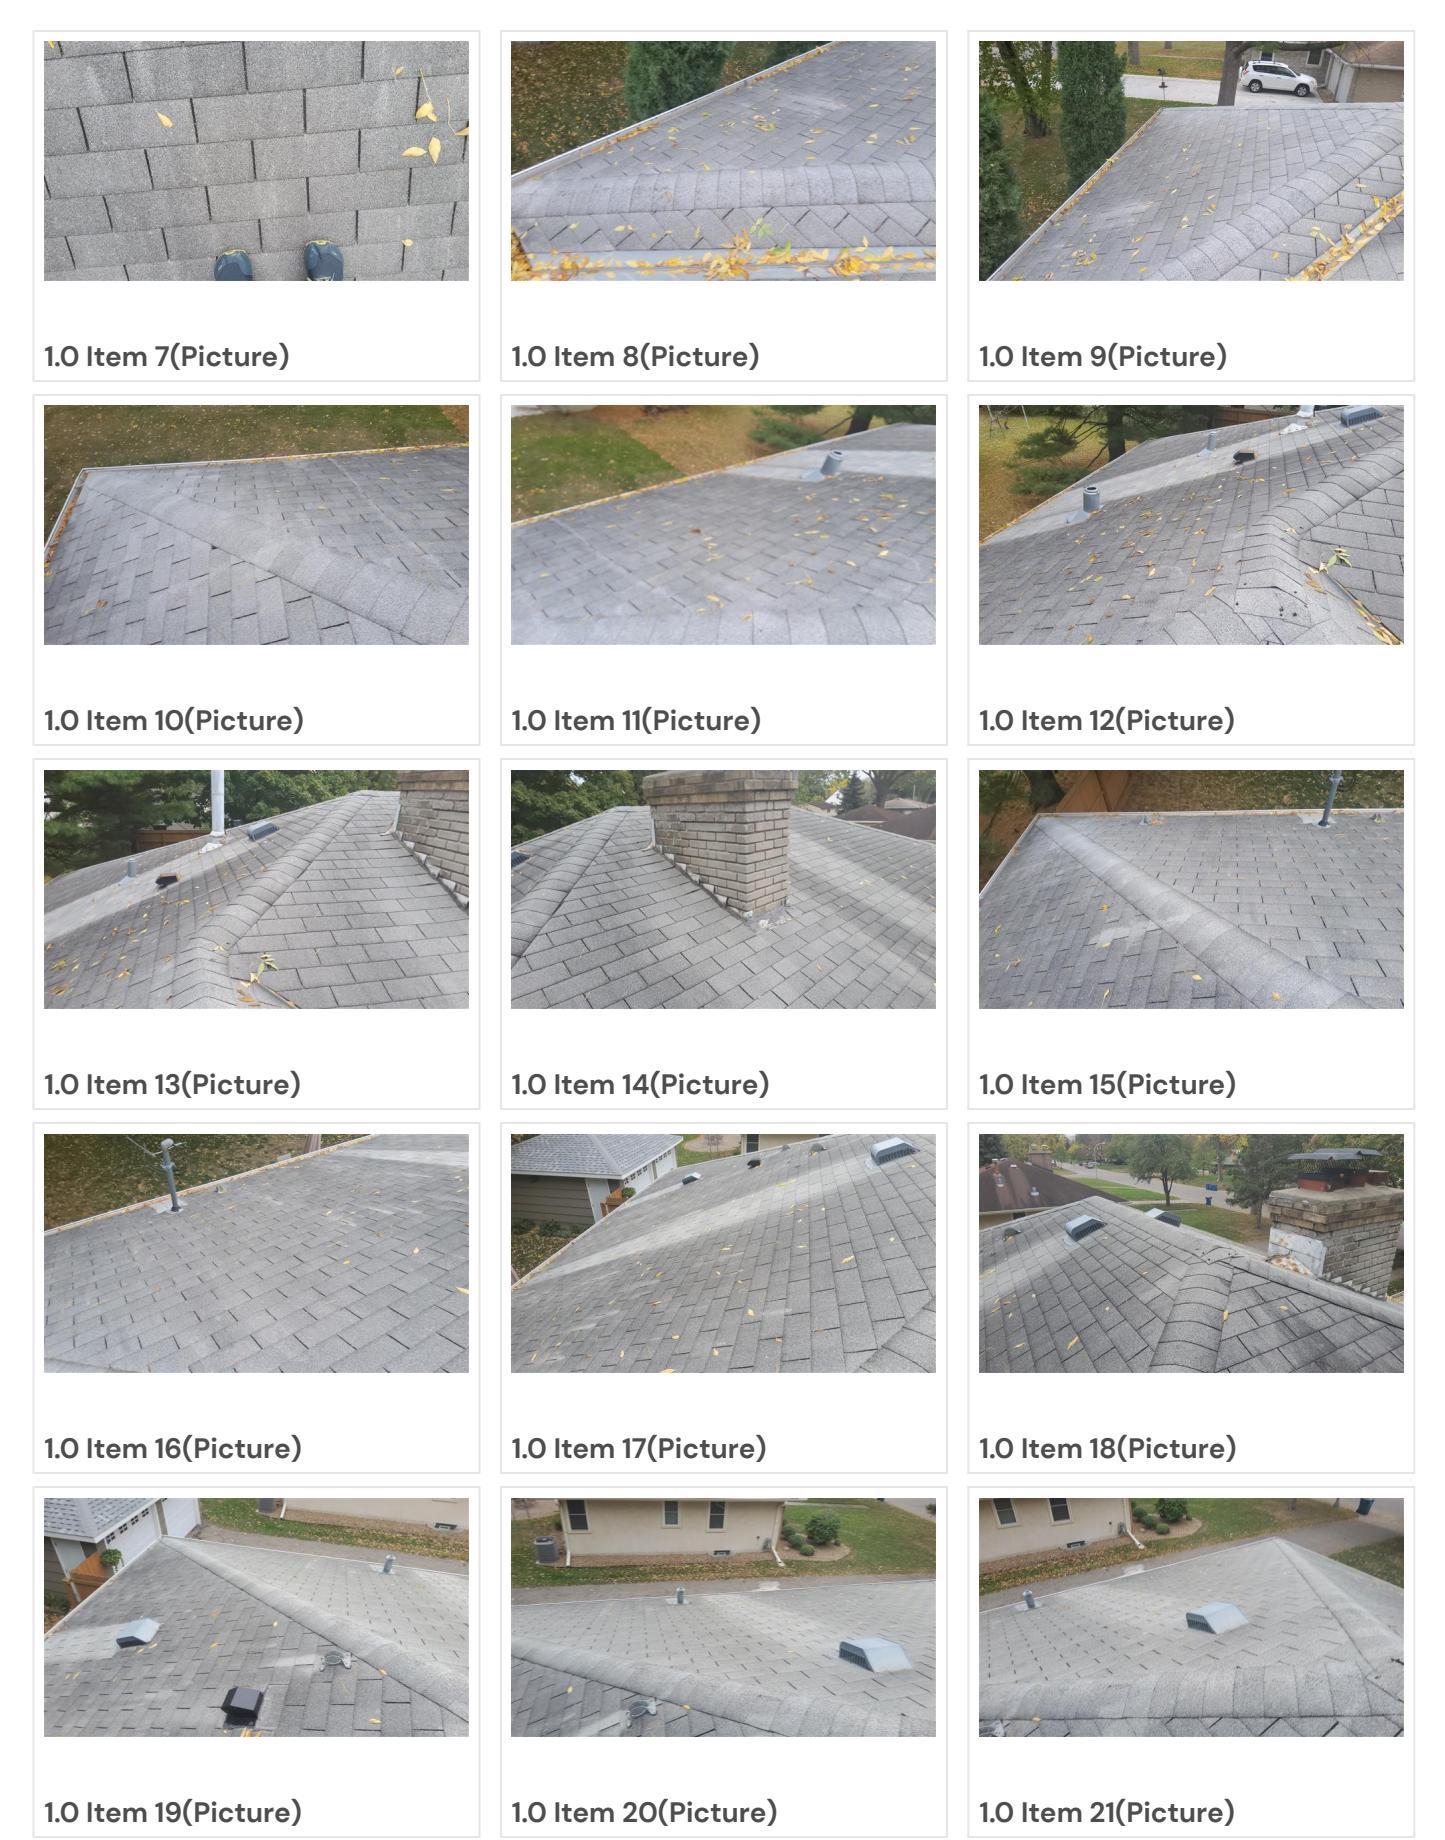
The shingles and other roofing components at the house appear to be aged but in fair condition. I estimate the shingles to be 16+ years old. The expected useful life of an asphalt shingled roof is 17–22 years. Replacement should be expected in the next 3–5 years

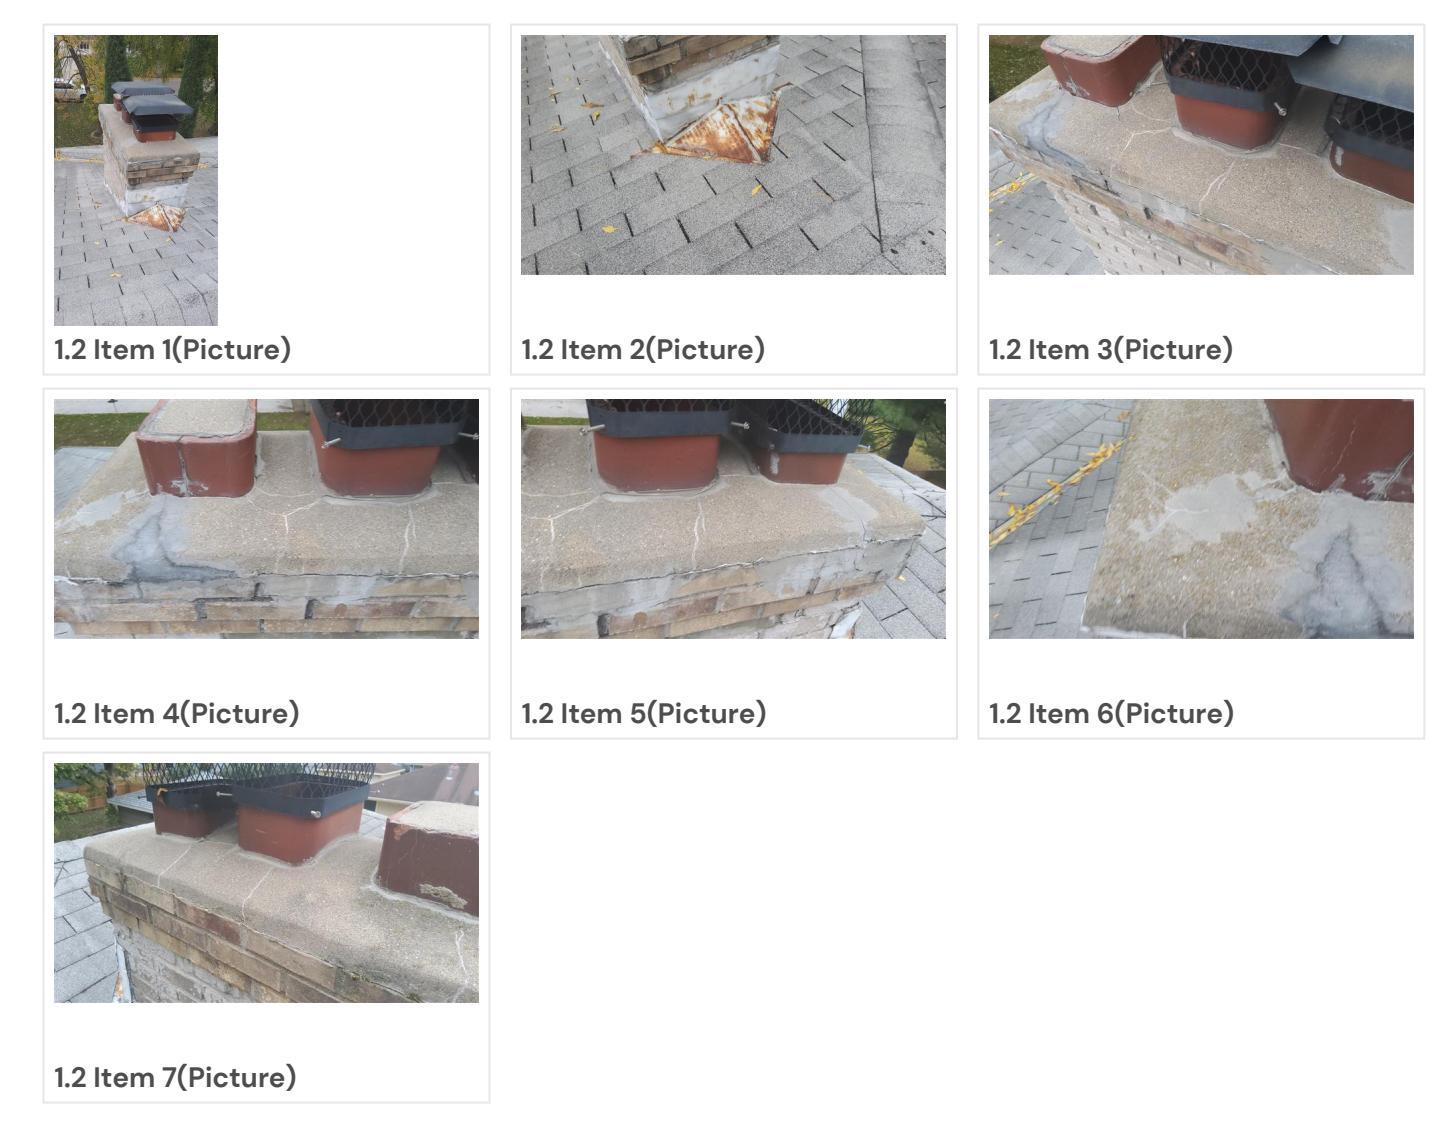
Cracking and deterioration of the concrete crown and bricks at the chimney. Further assessment by a certified chimney sweep is recommended. Repair as deemed necessary.

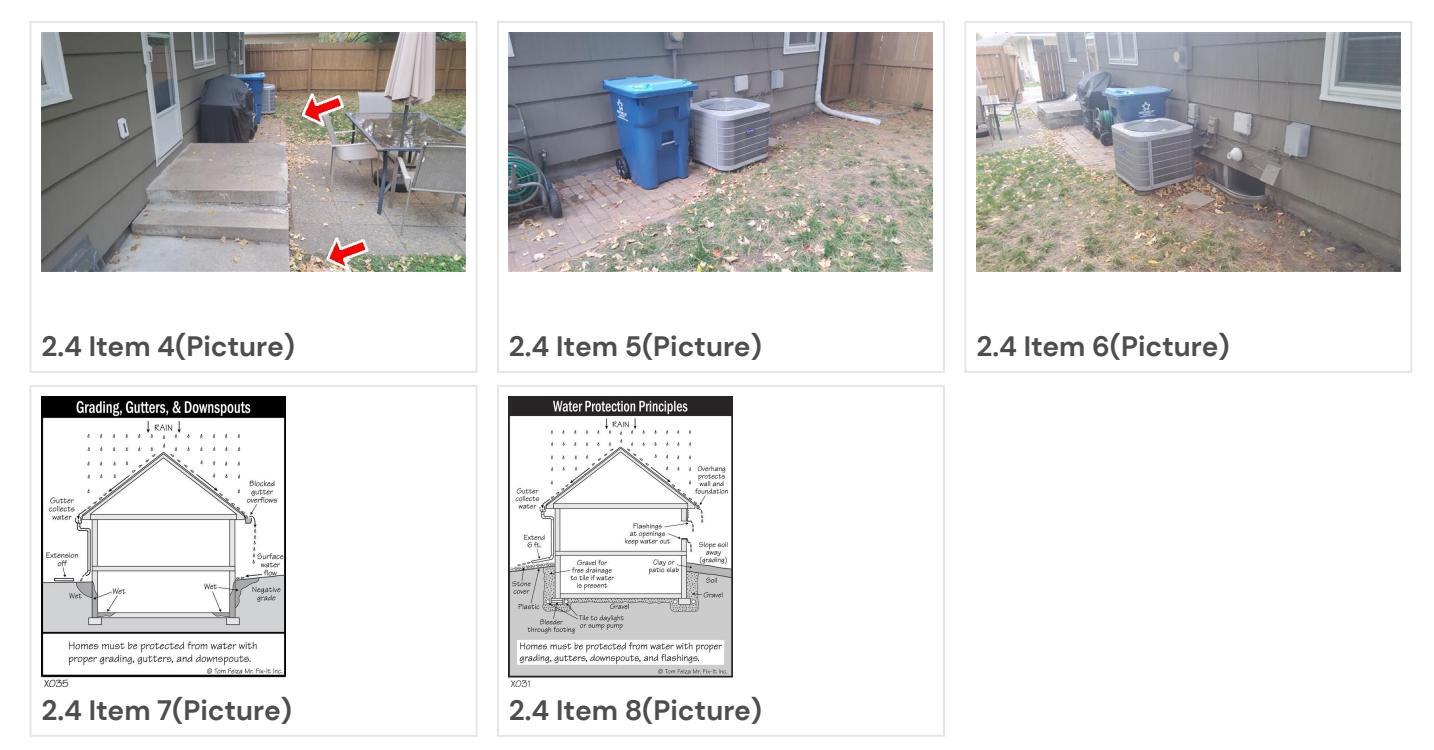
(2) Negative grading across the E side of the home. Areas of low and negative grading increases the risk of water intrusion at the foundation and basement. Grading is one of the most important aspects of keeping your foundation and basement dry. Ideally you would have a positive slope away from the home around the entire home of 6 inches over 10 feet. This is not always possible due to various lot restrictions and characteristics but is a good rule of thumb to keep in mind when assessing your landscape or if you are having water intrusion issues. Corrective grading and landscaping is recommended.

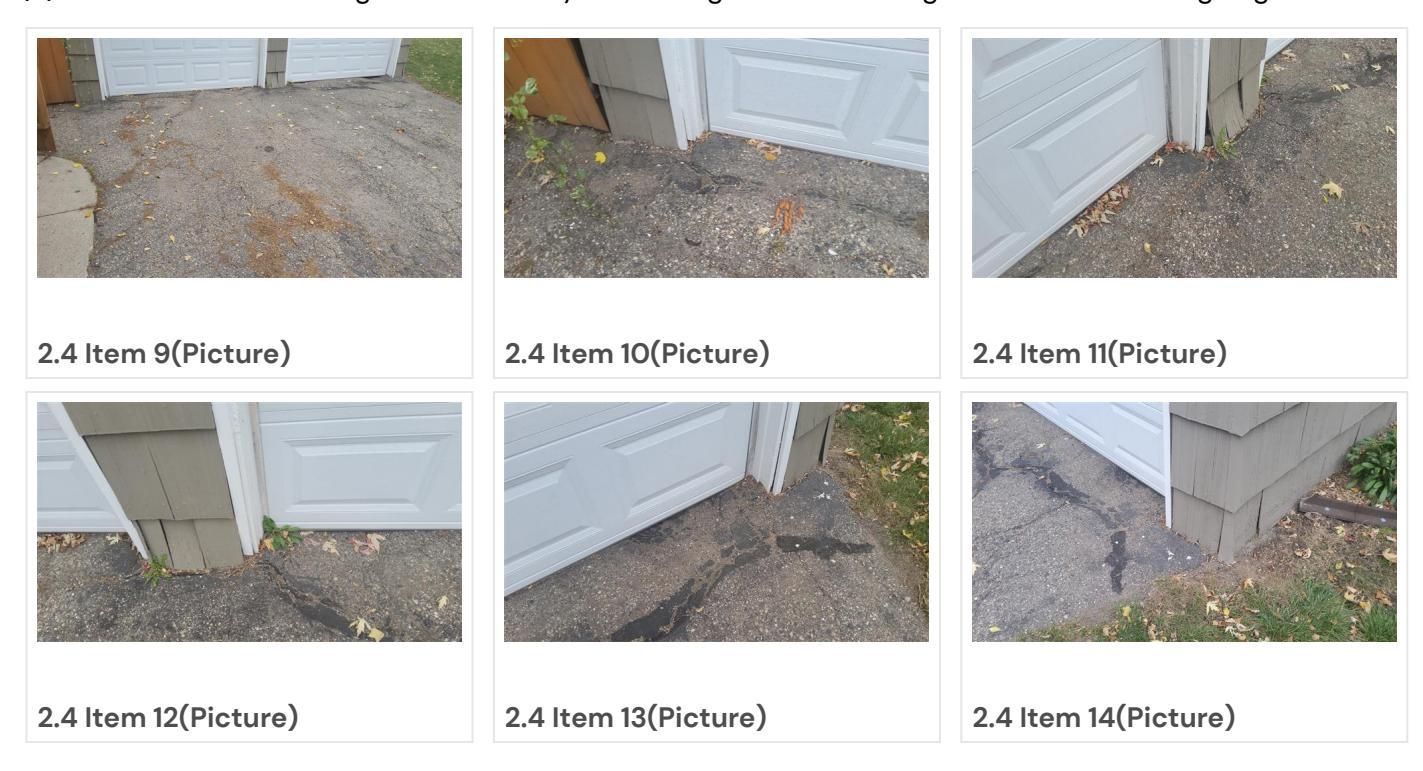
(3) Settlement and heaving of the driveway is resulting in visible damage at the front of the garage.

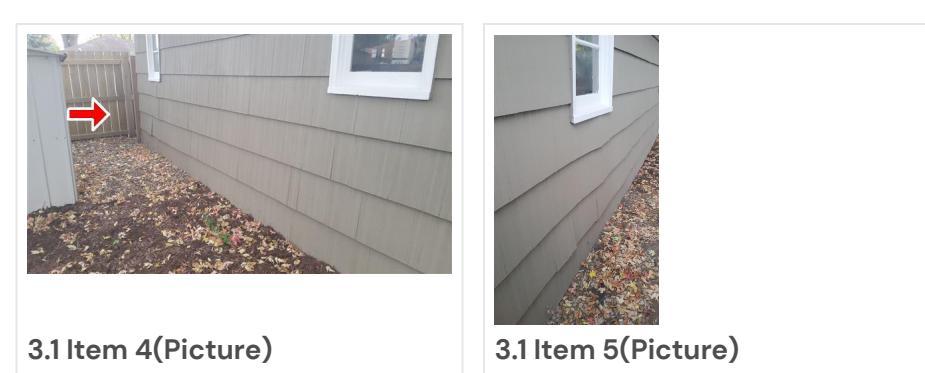
(2) The E wall of the garage appears to be pushed out at the S side. Repair or replacement is recommended

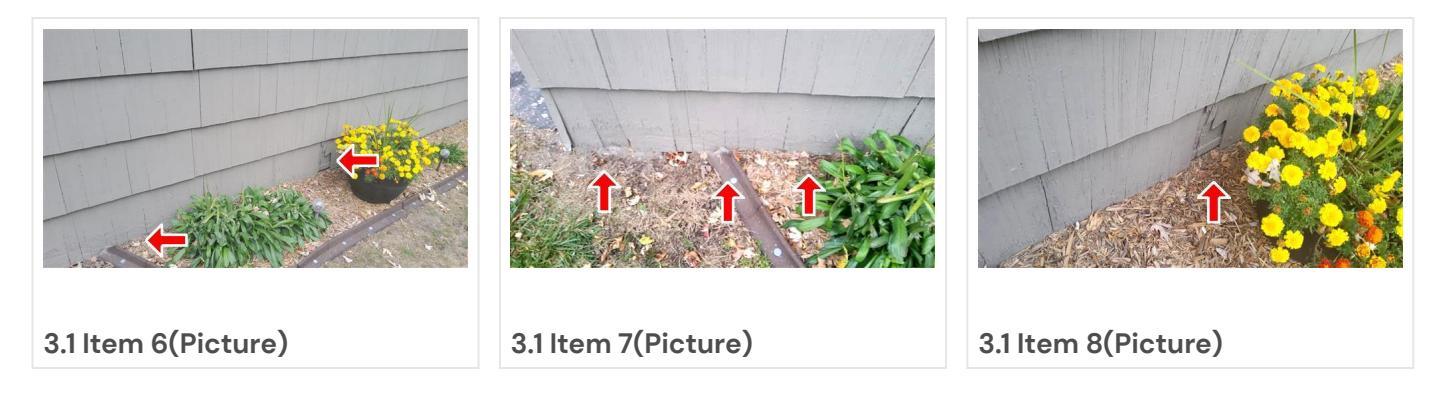
(3) Damaged siding at the S side of the garage. Replacement is recommended.

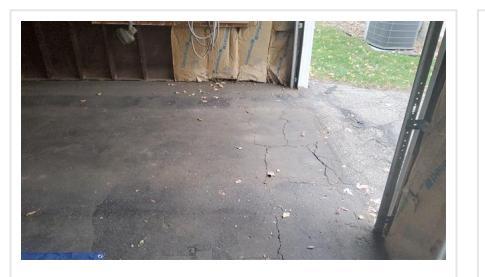
3.2 Item 1(Picture)

The garage floor is asphalt with settlement and heaving through out. The floor covers the sides of the sill plate and is not sloped in a specific fashion to the promote water drainage out in overhead doors. This increases the risk of water damage/deterioration of the wall structure. Removal and replacement with a properly draining floor is recommended.

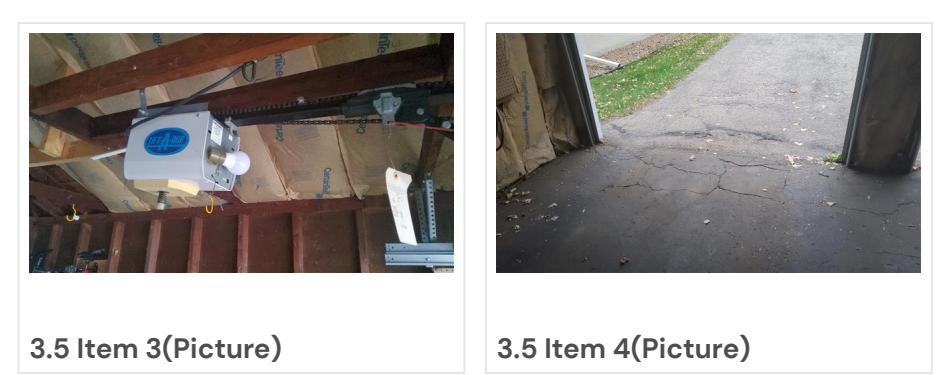
(2) The garage door opener at the S door is aged would not be serviceable due to the lack of modern safety equipment. Replacement with a modern garage door opener is recommended.

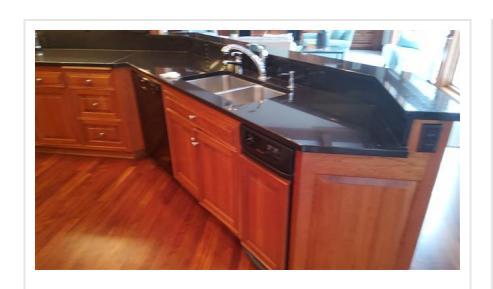
4.4 Item 1(Picture)

2 of the doors at the upper cabinet left of the sink are out of adjustment and difficult to close. Adjustment/ repair is recommended

This style of door, inset, is more likely to require seasonal adjustment due to expansion and contraction of the wood related to seasonal humidity changes.

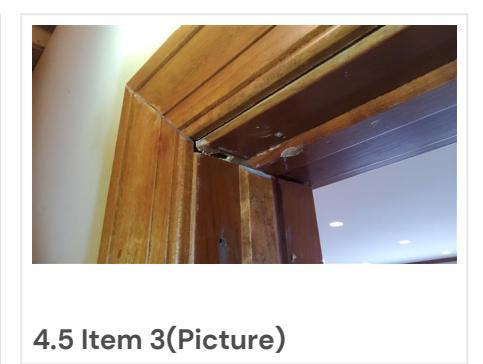
4.5 Item 2(Picture)

- 📋 INSPECTED
- (1) There are 11 interior doors on the main level. All are in functional condition.
- (2) Basement mechanical room door. The strike side upper corner of the jamb is broken. Repair or replacement is recommended.

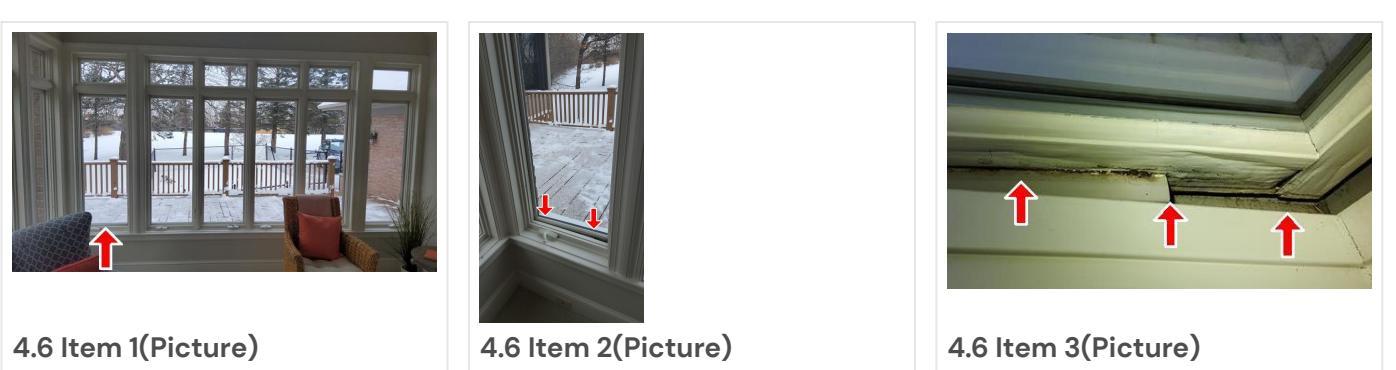
(2) The left sash at the N window in the sun room is rotten. Replacement is recommended.

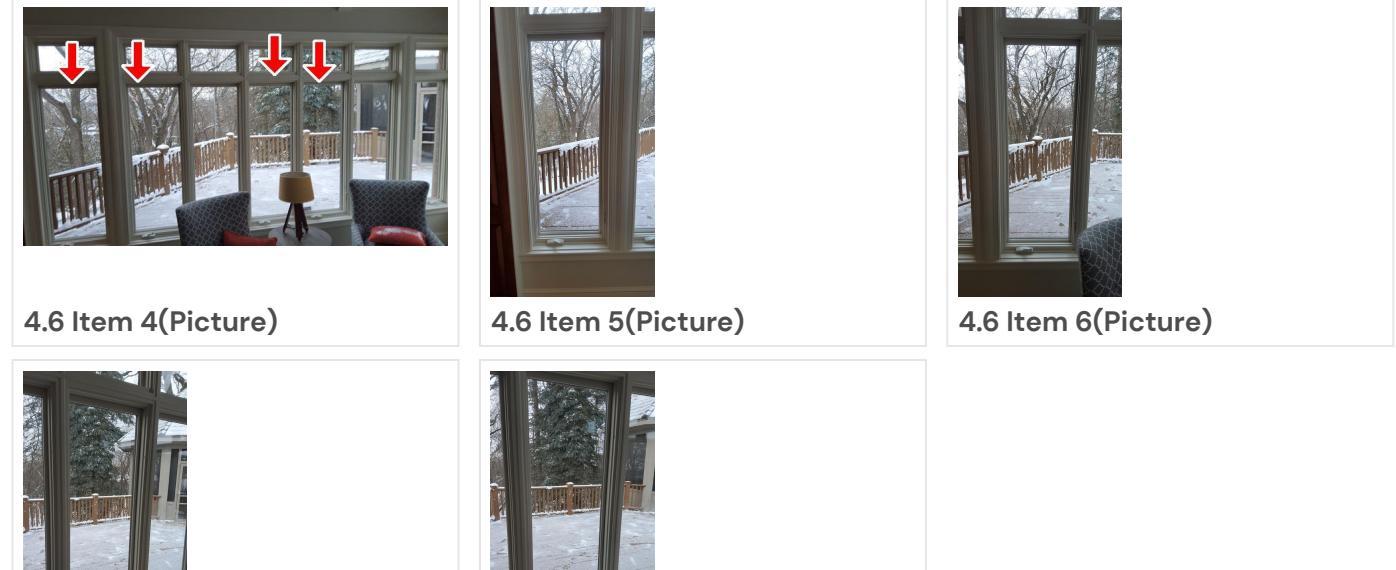
🚹 (3) W facing sun room window. Sashes 1, 2, 4 and 5 are frozen shut. I did not operate these sashes and was unable to verify the condition of the sashes.

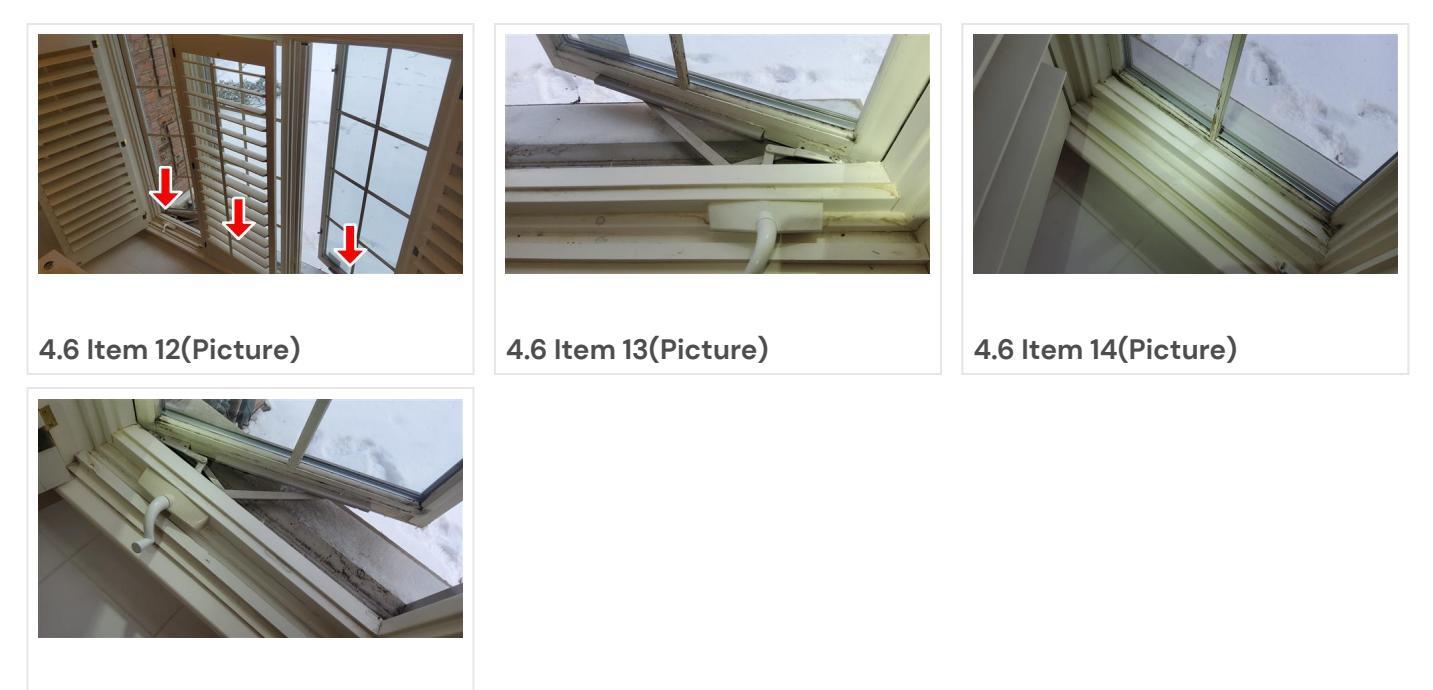
(5) Master bathroom window behind the tub. There is water staining and deterioration of the finish at all 3 sashes. The wood appears to be solid at this time. Sanding is and refinishing is recommended.

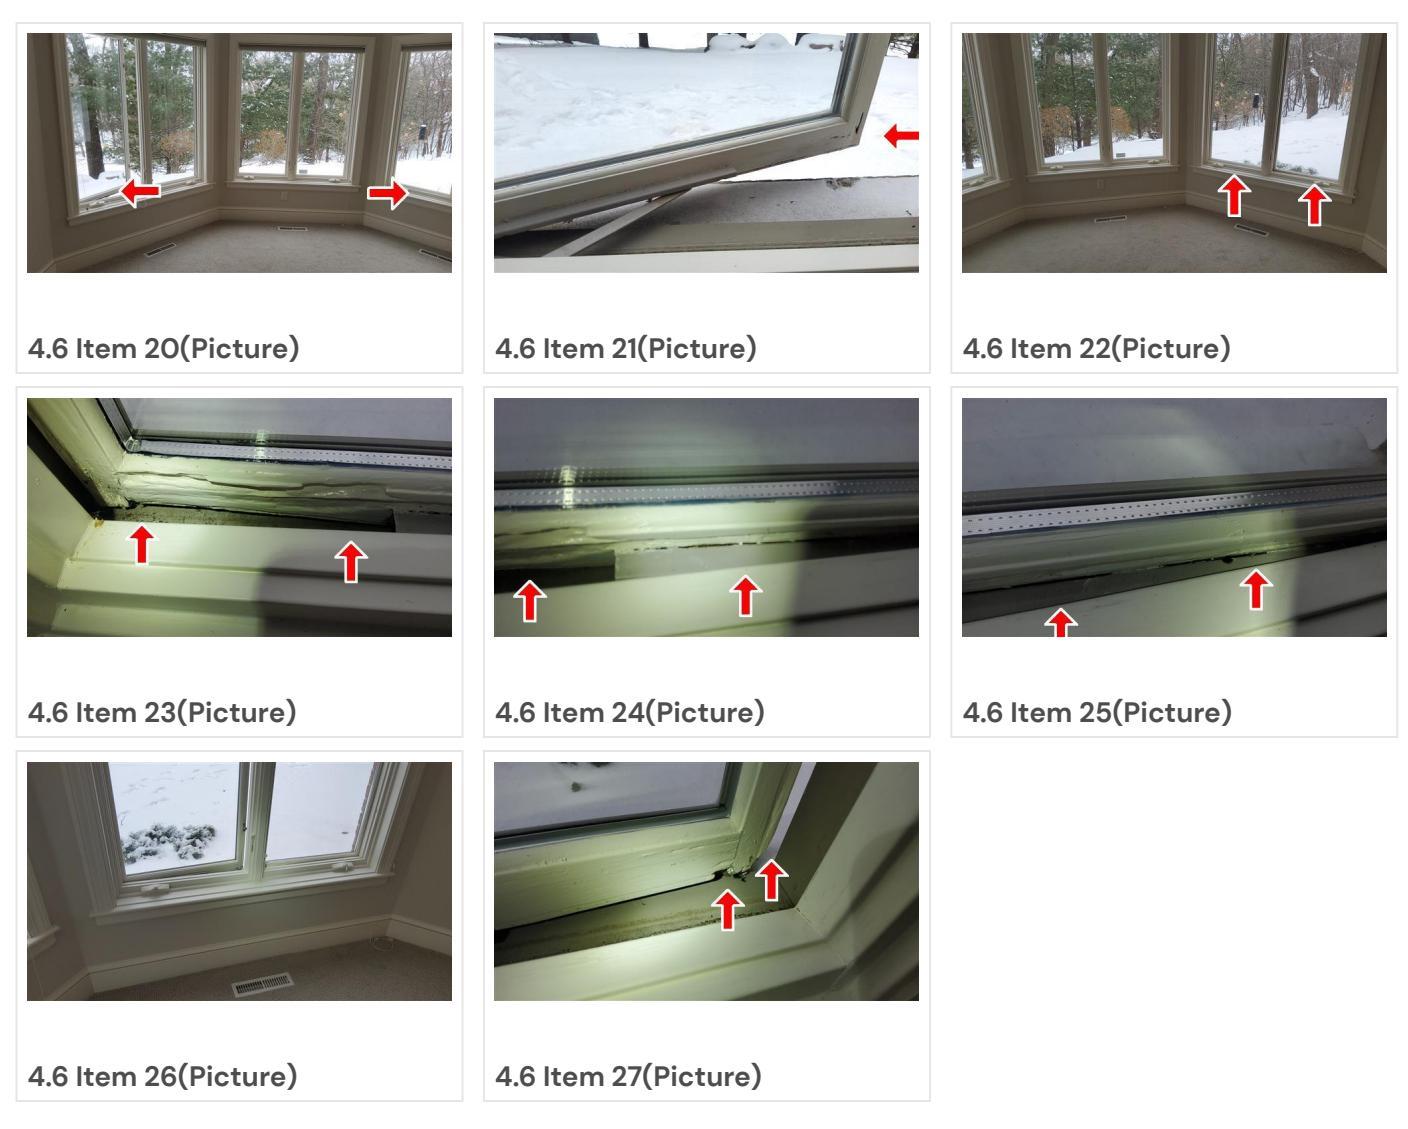
(7) SE basement bedroom. The left sash of the left window unit is rotten. Both sashes of the right window unit are rotten. Replacement is recommended.

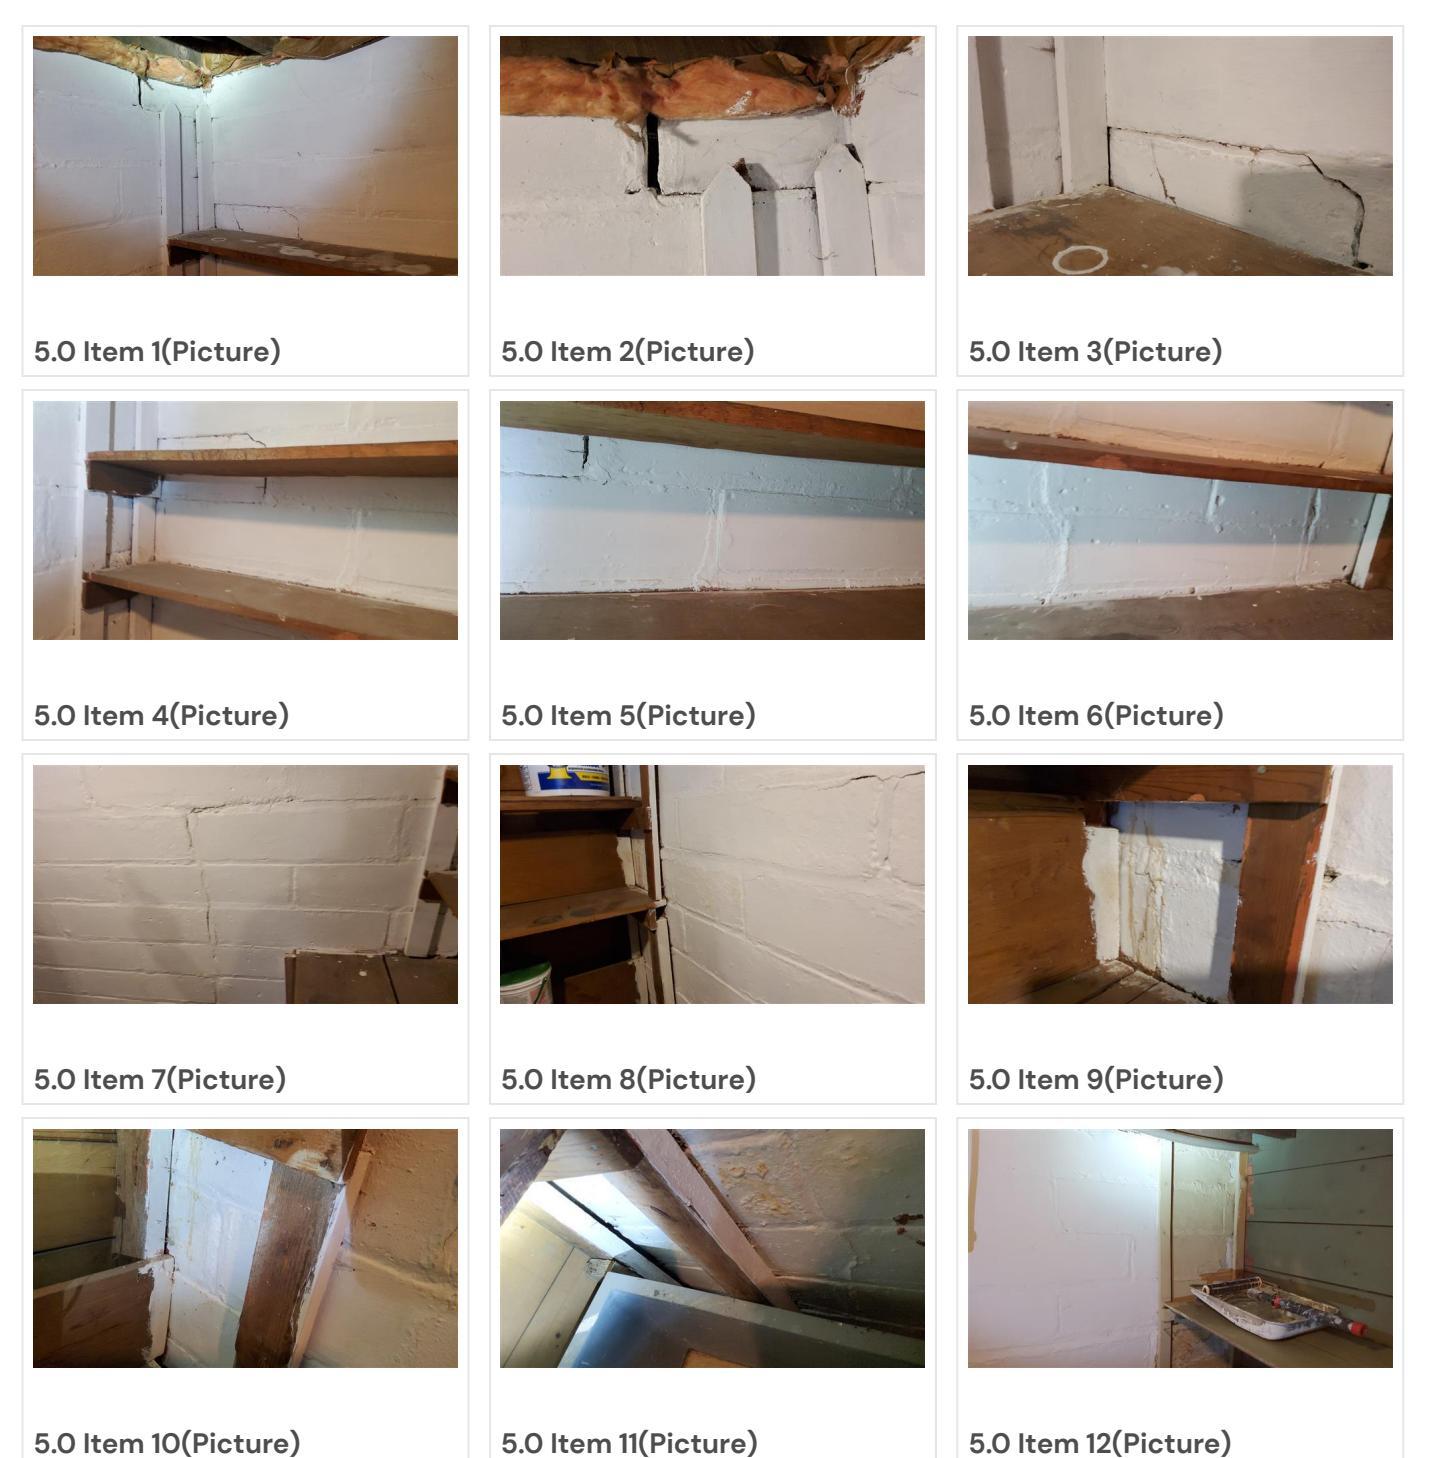
There is cracking, shifting and water staining at the visible portions of the foundation at the NW corner and across the front of the home. Movement of the foundation is a likely cause for some of the cracking that was noted at the brick and stucco. This movement/deterioration could be the result of past water intrusion of frost related problems. Tuck pointing or sealing of cracks and monitoring for further movement is recommended. Ensuring proper water movement away from the foundation will help in deterring further movement

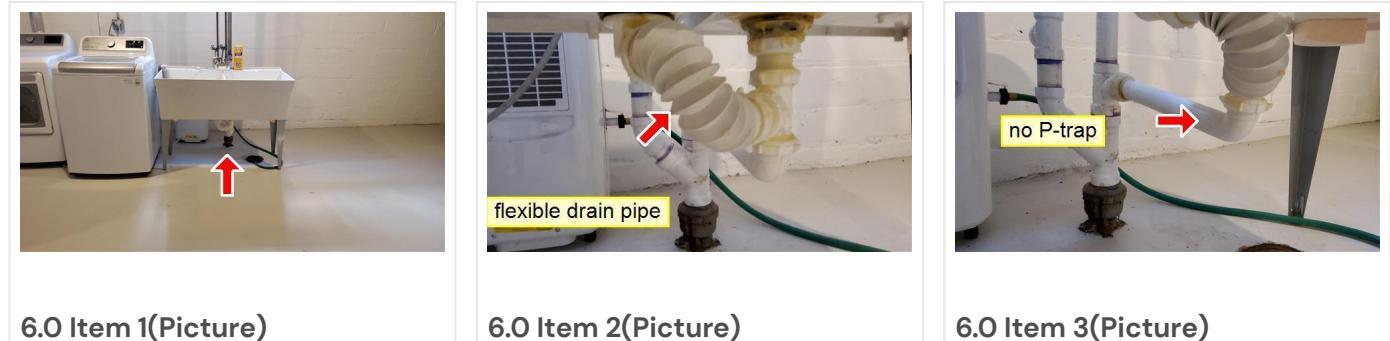
🔁 (1) The drain at the basement utility sink is lacking a p-trap and is using flexible drain pipe. A p-trap is required and stops sewer gas from rising into the home. Flexible pipe is prone to clogging and leaking. Replacement of the drain to modern code by a licensed plumber is recommended.
