# **Inspection Report**

# Sample Report

Property Address: 1234 Sample Blvd Sampletown MN

## Solid Foundations Home Inspections

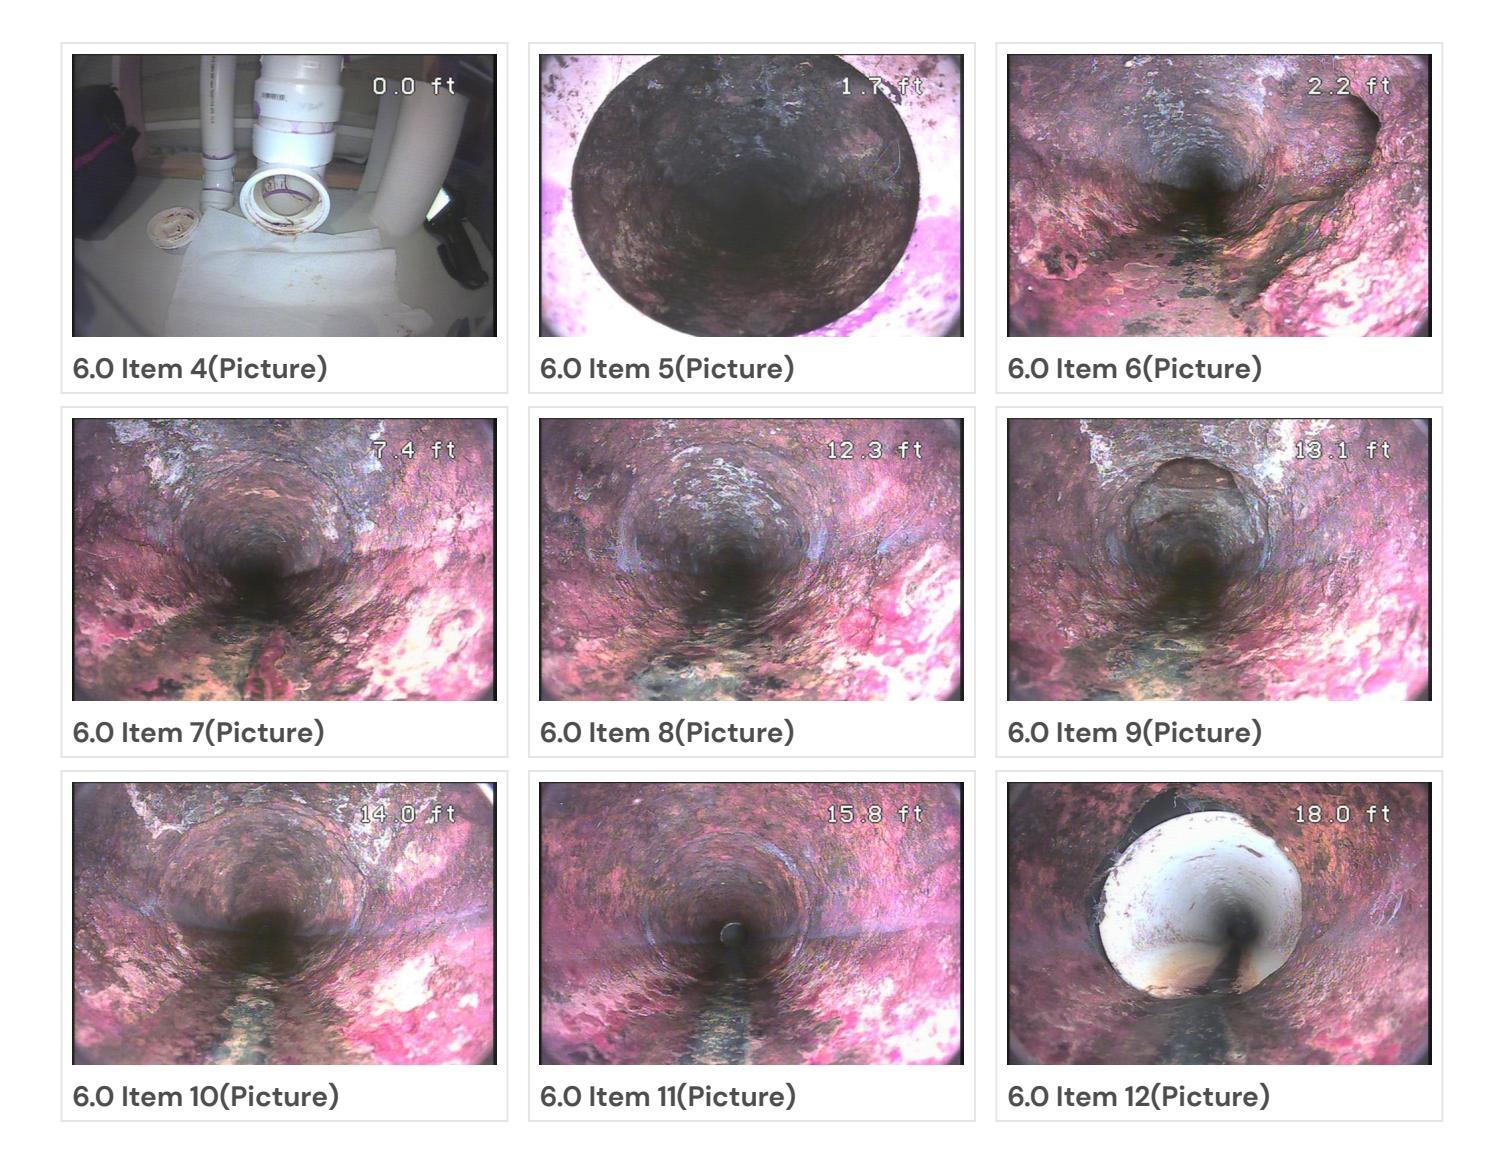
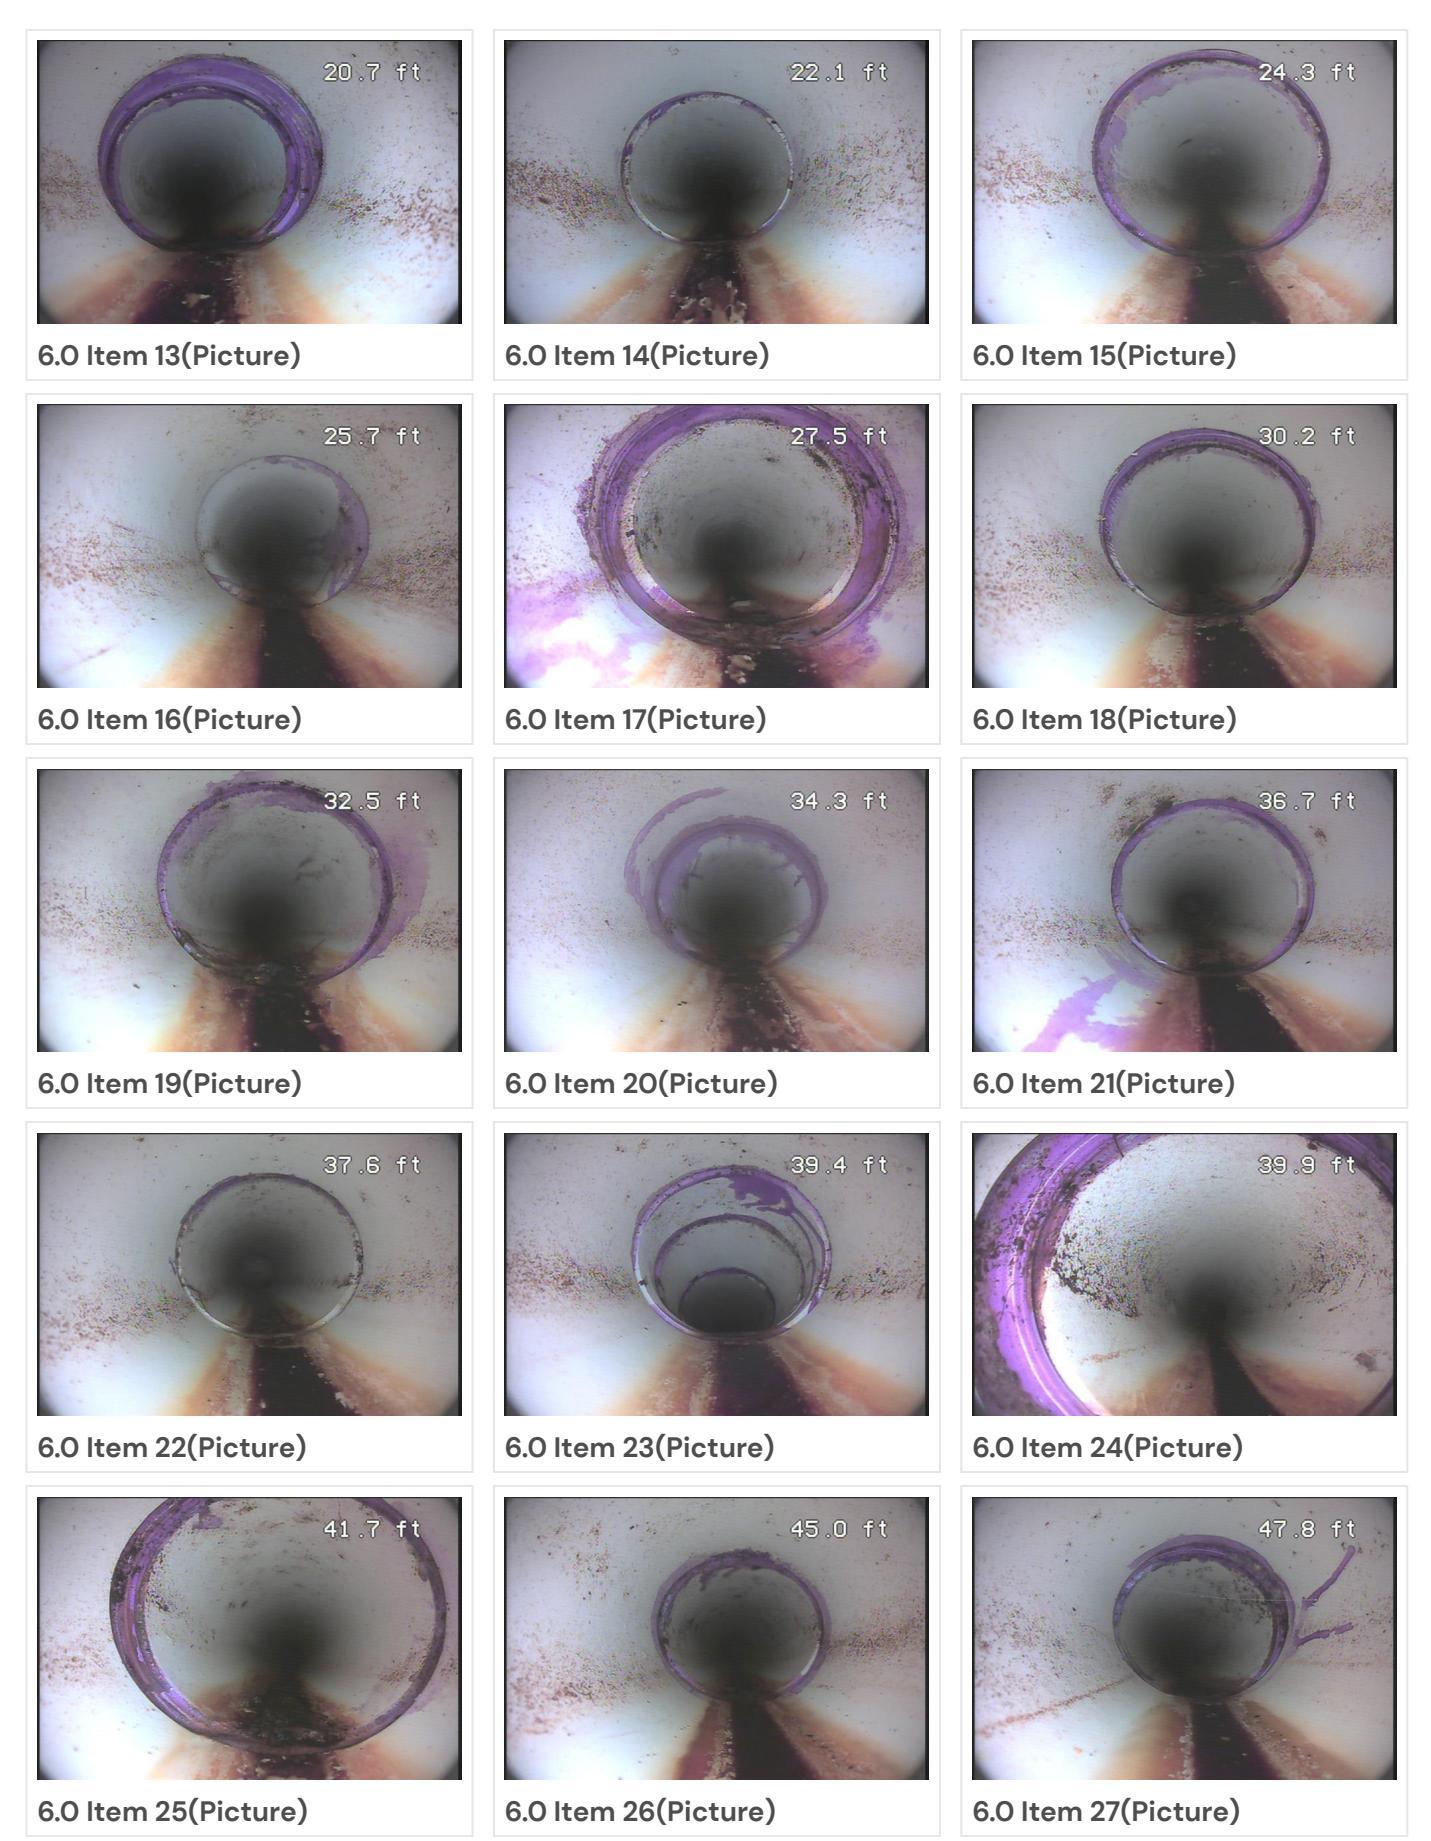
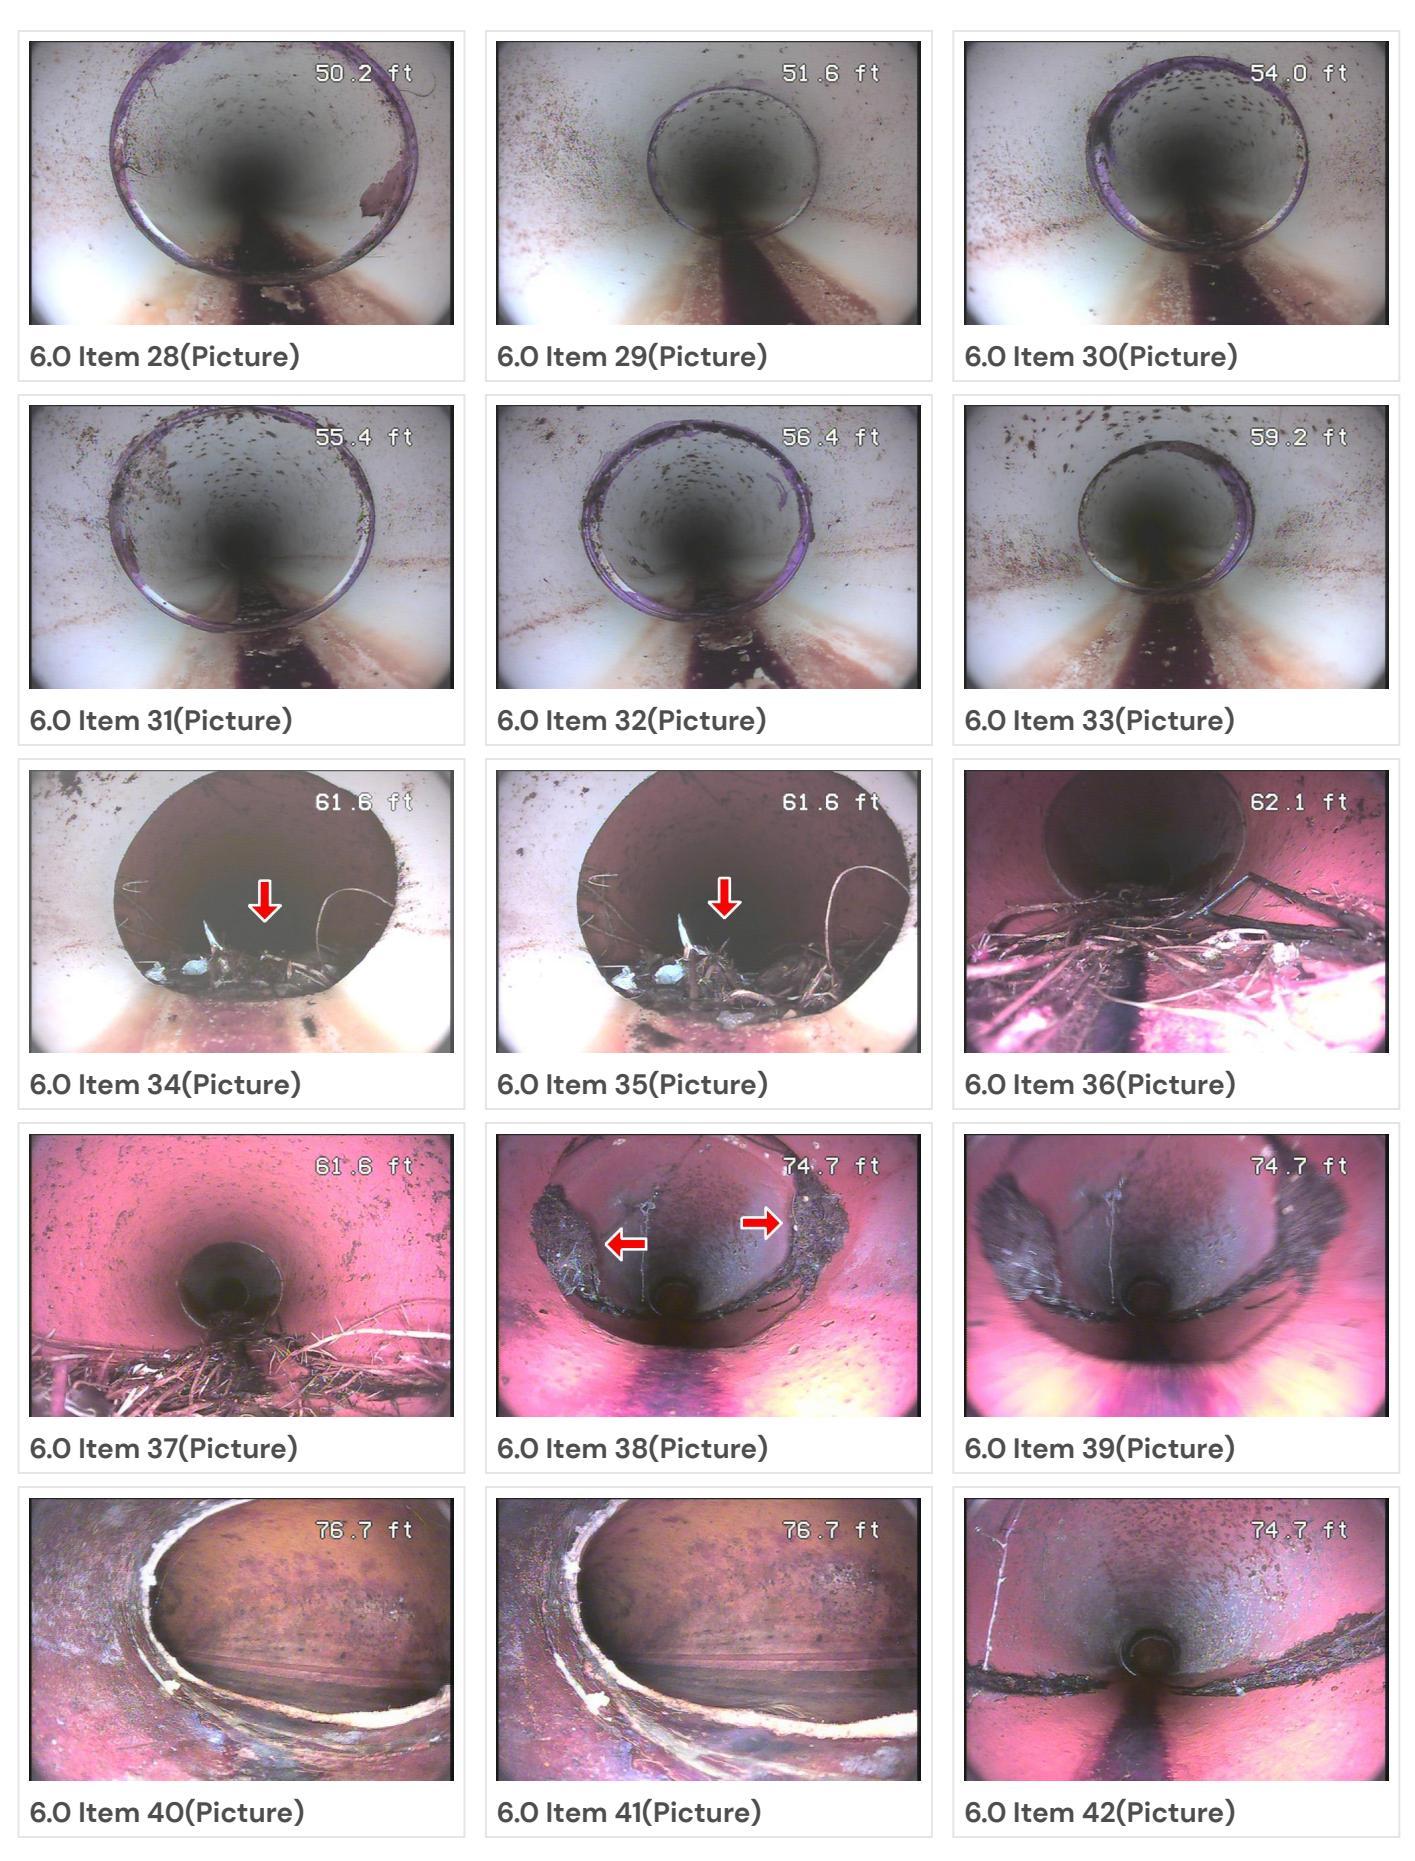
6.0 Item 2(Picture)

😤 (2) A camera inspection of the lateral sewer line was performed from the clean out plug at the stack near the boiler to the city connection at 76 feet. There was some root growth and debris at the transition from PVC to clay (about 61 feet) and again at about 72 feet. Cleaning and re-inspection by a qualified sewer contractor is recommended.

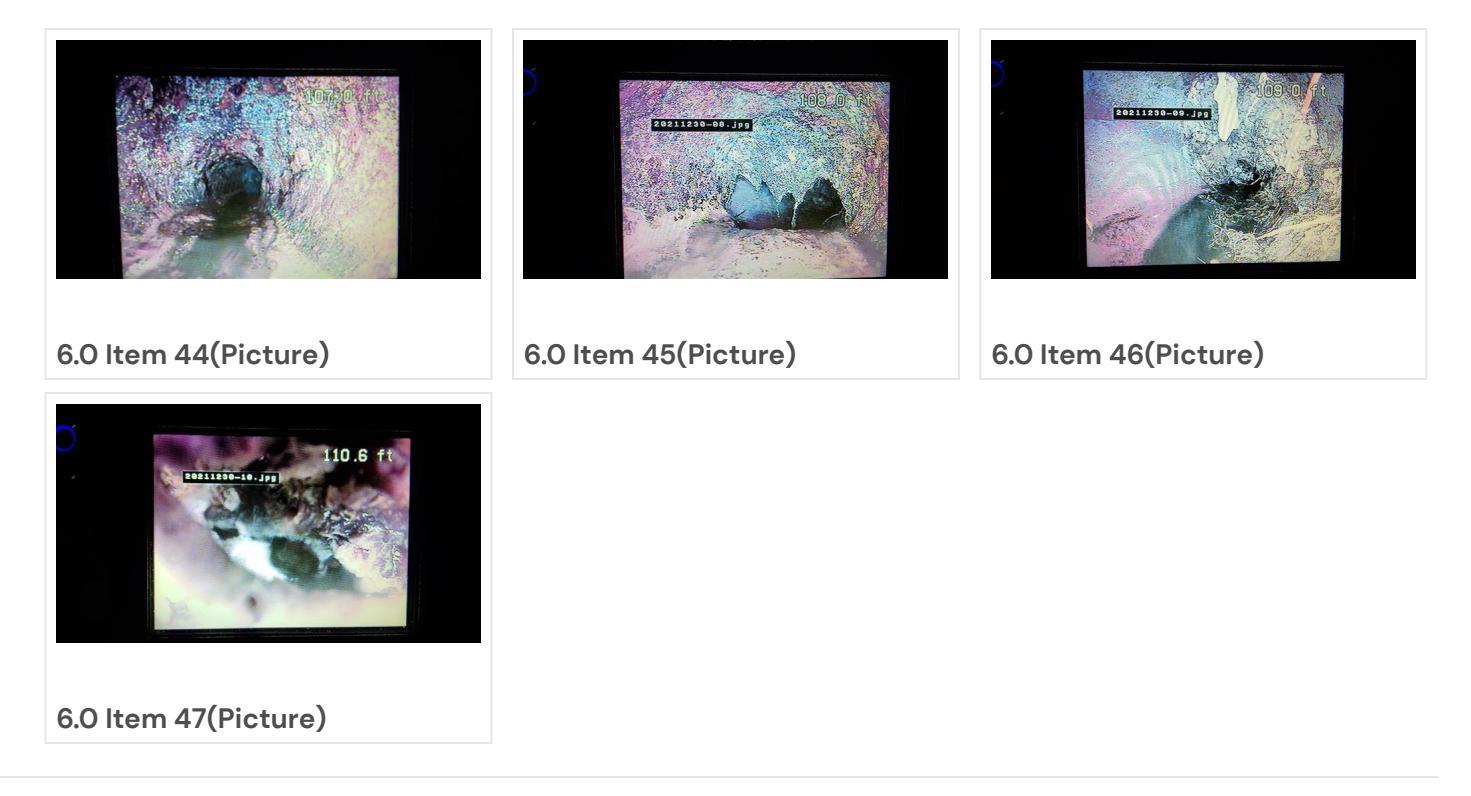
(4) A camera inspection of the lateral sewer line was performed from the clean out plug at the S side of the basement. The first 89 feet is clean 4 inch PVC pipe. It transitions to cast iron pipe at this point with heavy scaling throughout and root growth start at 109 feet and becoming impassable at 110 feet. Cleaning and re-inspection by a qualified contractor is recommended. Need for repairs may be found in this process. Copy and paste the following link to your browser to view the video of the sewer inspection-https://youtu.be/ZcOpmPexxvw

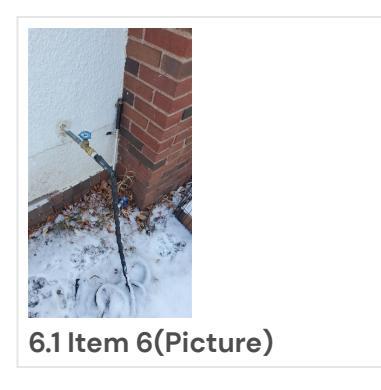
(2) The hose was left attached to the exterior spigot at the SW corner of the home. This increases the risk of water freezing and burst pipes. Removal of hose and draining the water line is recommended.

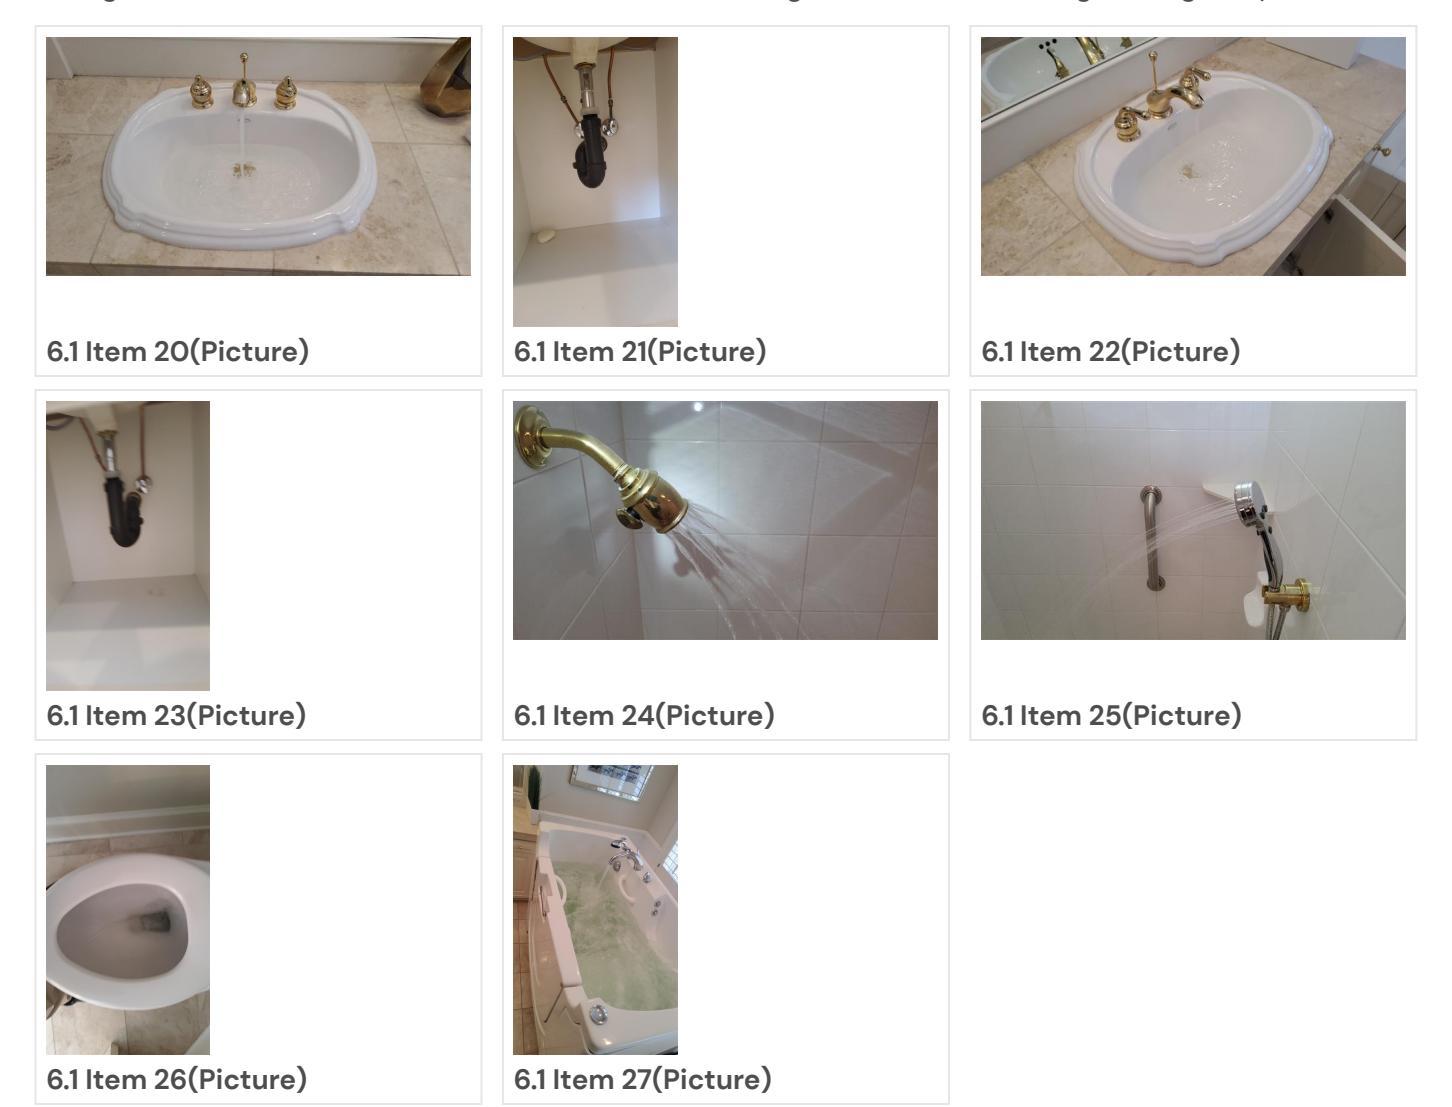
(7) Master bathroom plumbing fixtures. I ran water through all of the fixtures for several minutes. There leaking at the tub fixture, there was no further visible leaking or obstructed drainage during this process.

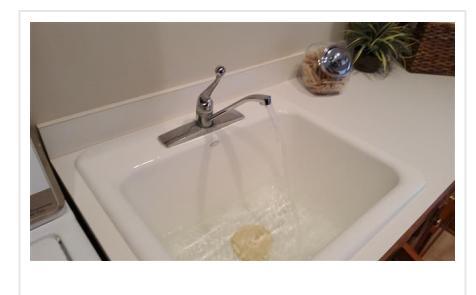
6.1 Item 34(Picture)

(10) Main level laundry room utility sink fixture is leaking. Repair or replacement is recommended.

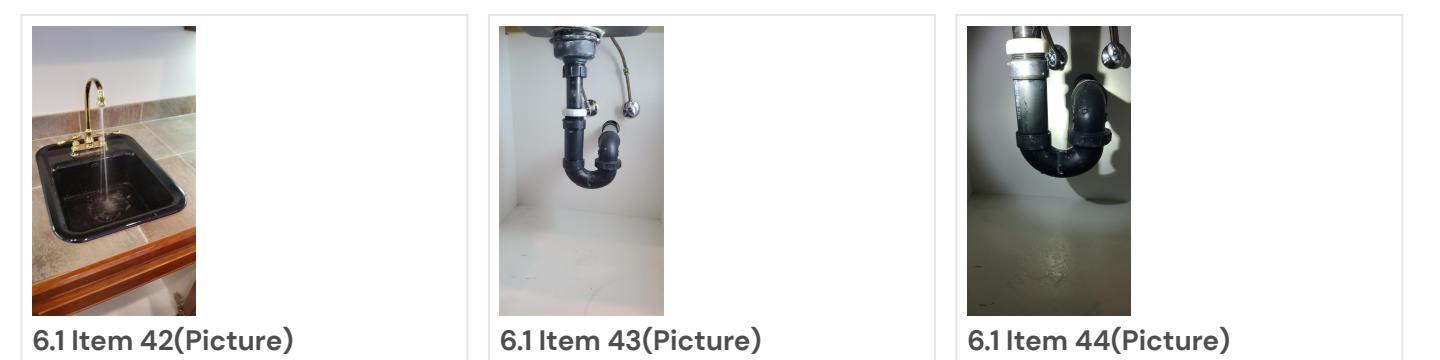
(12) Basement wet bar sink. I filled and drained the sink. There was a leak at the drain during this process. Repair is recommended.

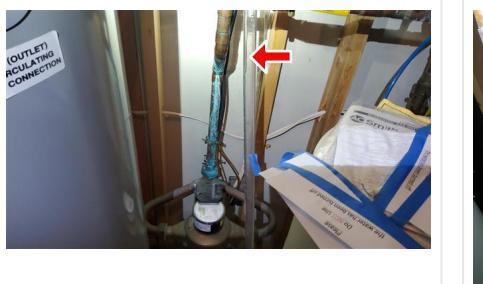
(15) There is leaking at the main water line just above the water meter. Repair by a licensed plumber is recommended.

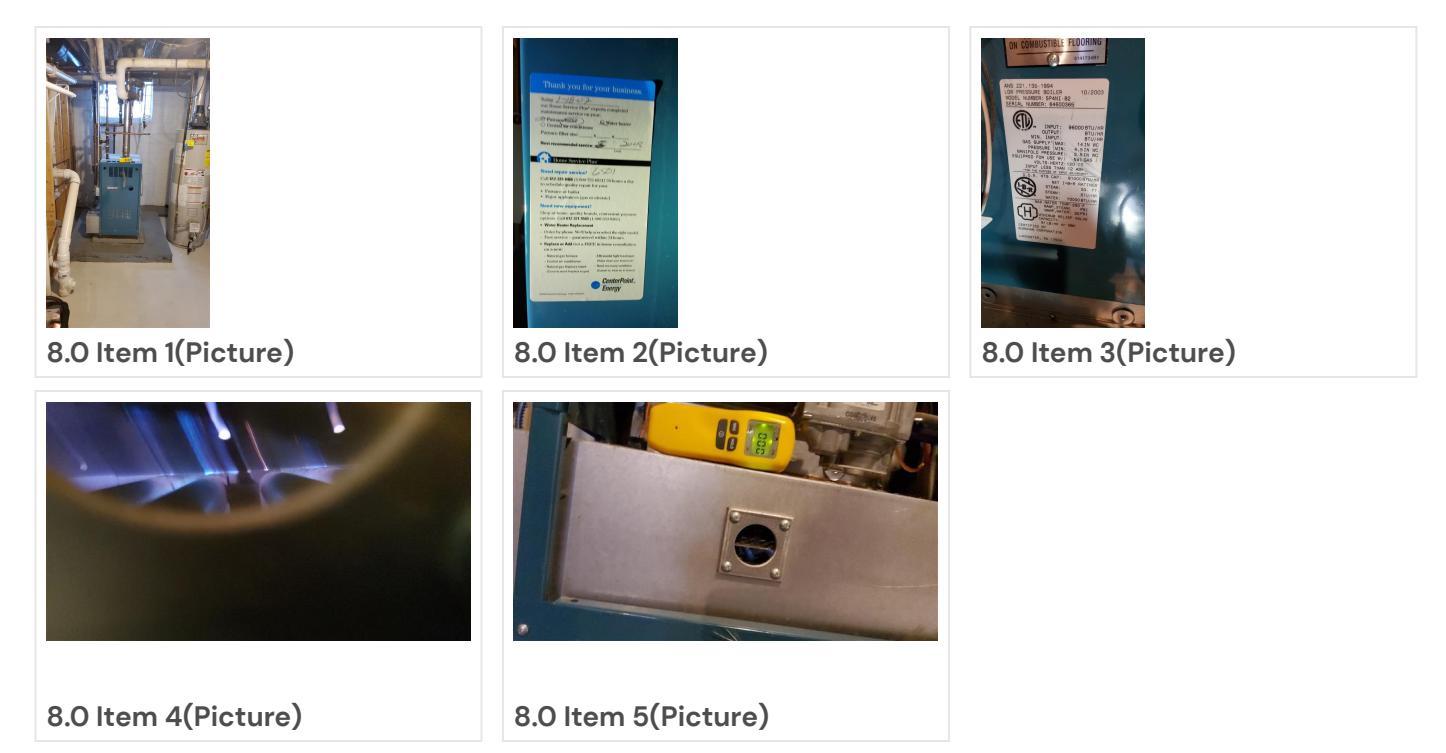
The circulating boiler was manufactured in 10/2003, the expected useful life of a circulating boiler is about 25 years. The boiler is in functional condition and has an even blue flame at the burners through out the heating cycle. The CO reading near the boiler during operation was 0 ppm. I always recommend having the boiler tuned and cleaned annually by a licensed plumbing and heating contractor, the most recent service appears have been in 2007. A full cleaning and tune up by a licensed plumbing and heating contractor is recommended at this time.

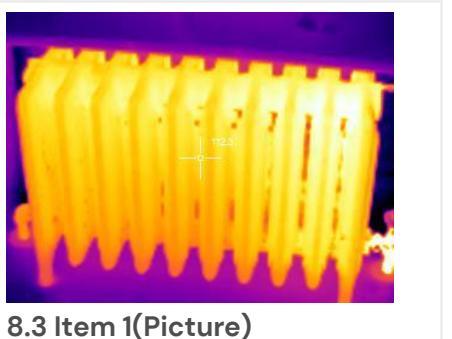
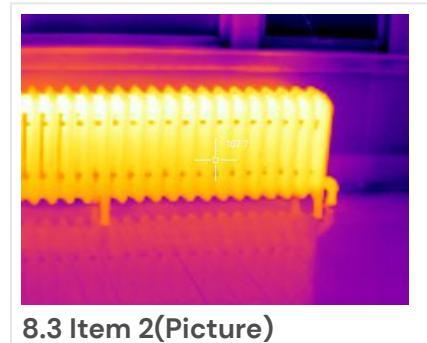
- INSPECTED
- (1) There are 12 radiators in the home. 1 is not heating properly the remaining are in functional condition.

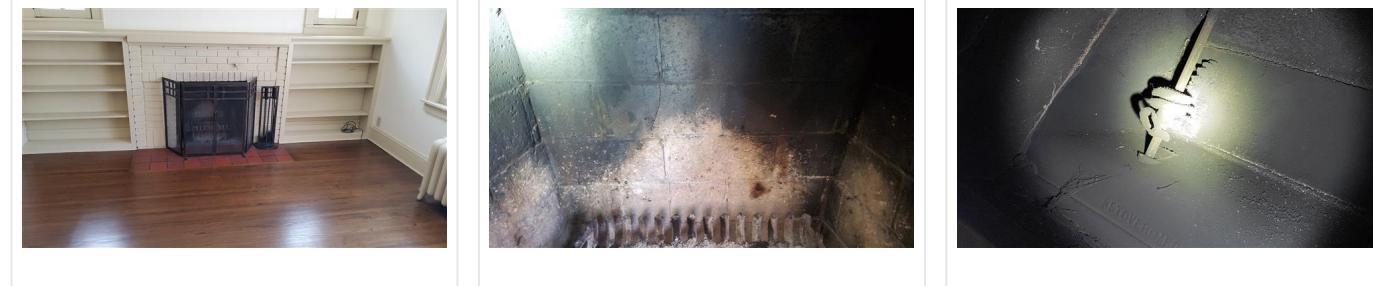
8.6 Item 1(Picture)

Main level family room wood burning fireplace. There is some cracking at the fire bricks and mortar. The flue damper operating mechanism is not working. Further assessment by a qualified chimney sweep is recommended. Repair or replace as deemed necessary.

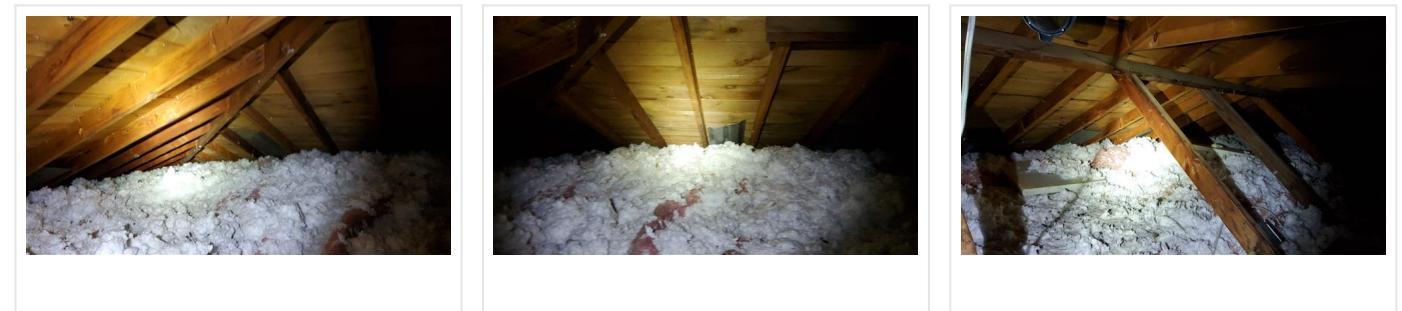
9.0 Item 1(Picture)

There is about 12–14 inches of blown fiberglass insulation at the attic. Modern standard is R49 or better, about 16–18 inches depending on the specific insulation used. Additional insulation is recommended for greater energy efficiency of the home.

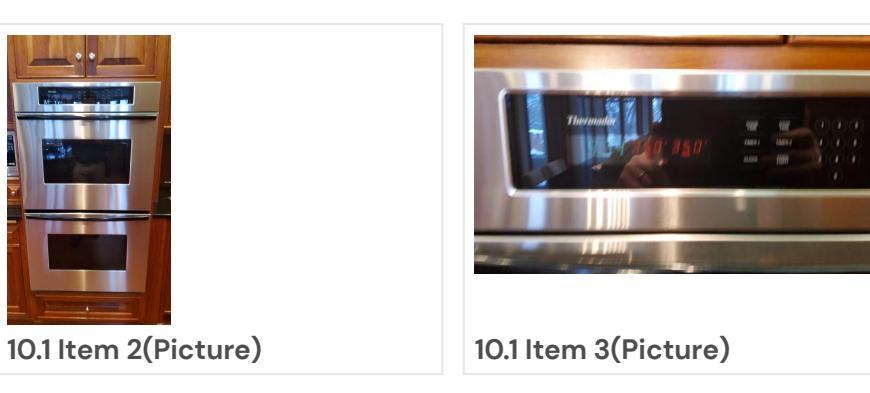
(2) The ovens make a vibrating noise when operating. Repair or replacement is recommended.

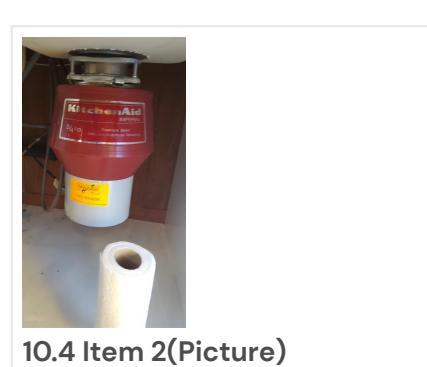
The shroud at the opening to the disposal is torn and mostly missing. The disposal is in otherwise functional condition. Replacement is recommended.
