# **Inspection Report**

# Sample Report

Property Address: 1234 Sample Blvd Sampletown MN

## Solid Foundations Home Inspections

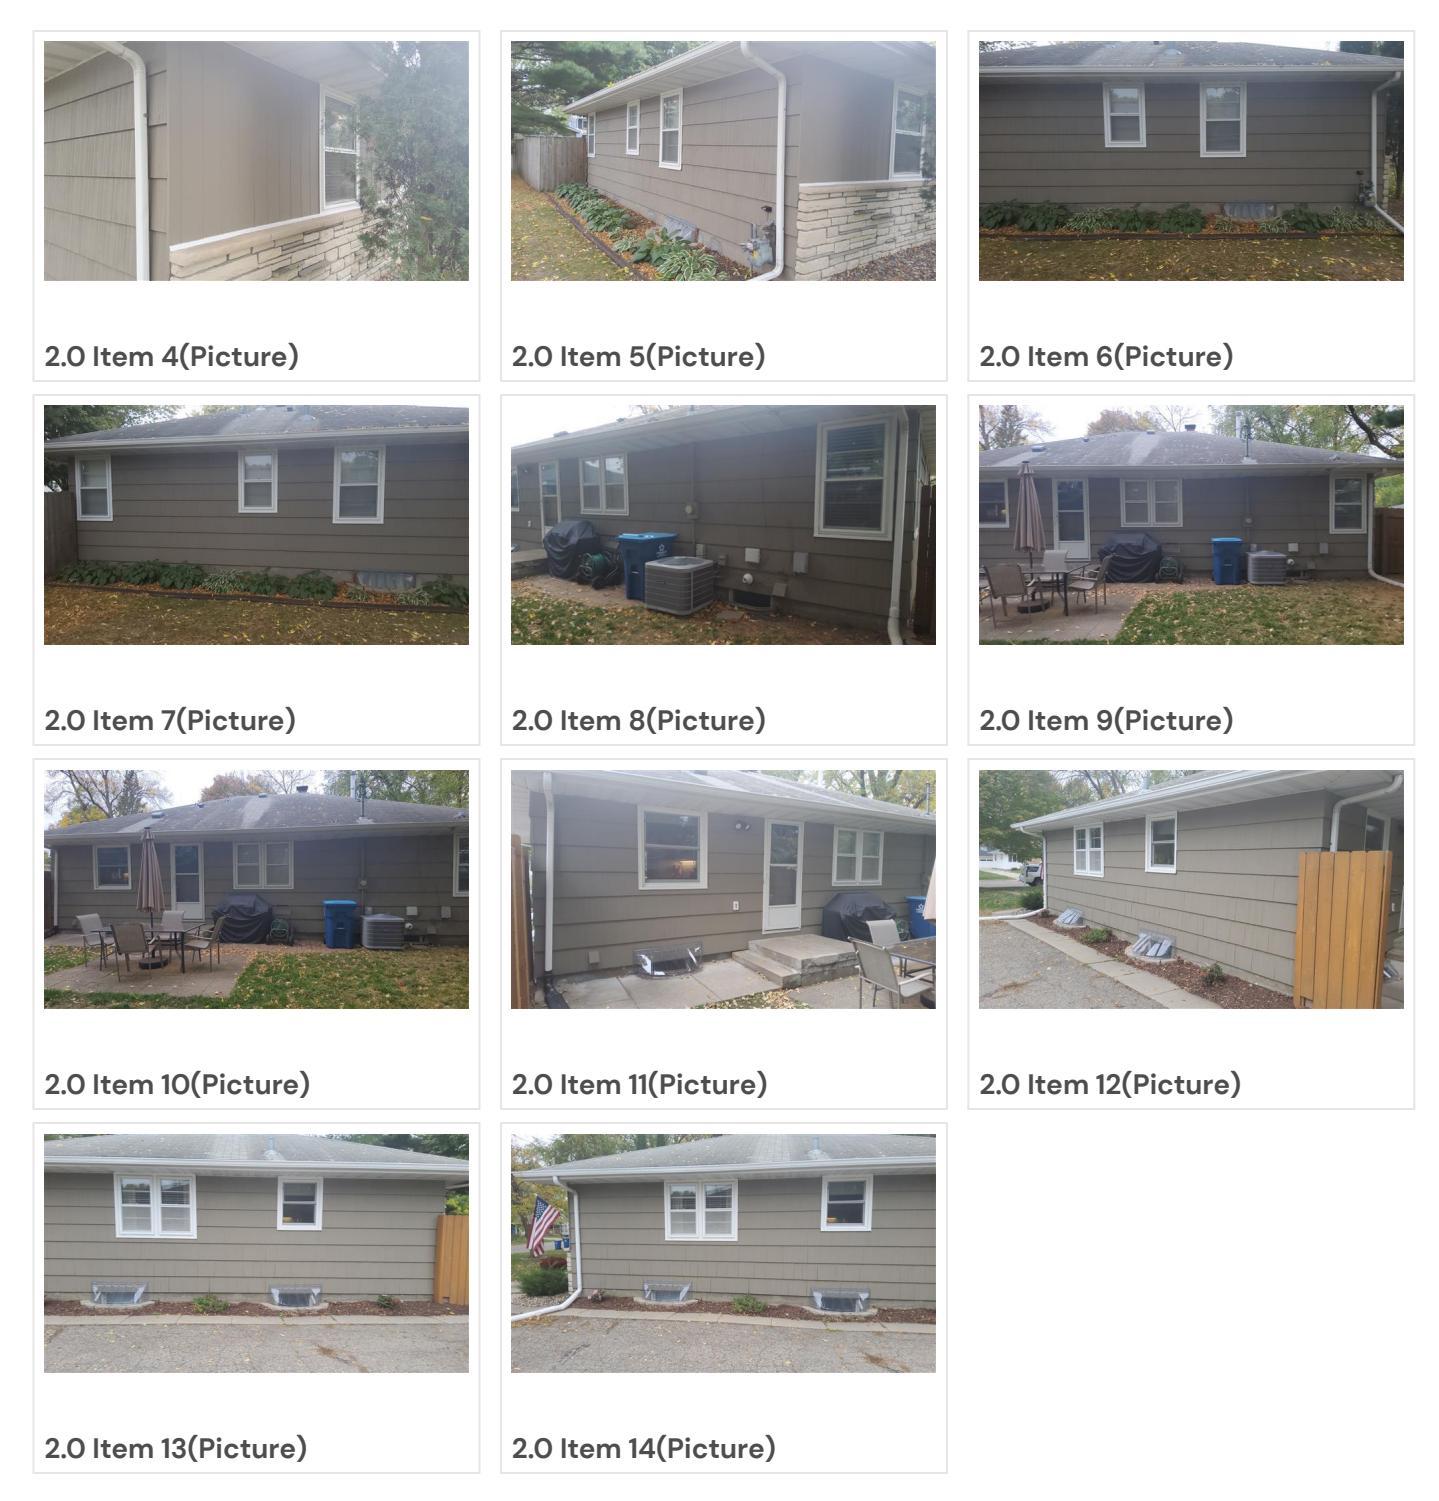
(1) Settlement of the driveway and sidewalk at the S side of the home has created a negative slope toward the foundation. This increases the risk of water intrusion at the foundation and basement.
Grading is one of the most important aspects of keeping your foundation and basement dry. Ideally you

would have a positive slope away from the home around the entire home of 6 inches over 10 feet. This is not always possible due to various lot restrictions and characteristics but is a good rule of thumb to keep in mind when assessing your landscape or if you are having water intrusion issues. Corrective grading and landscaping is recommended.

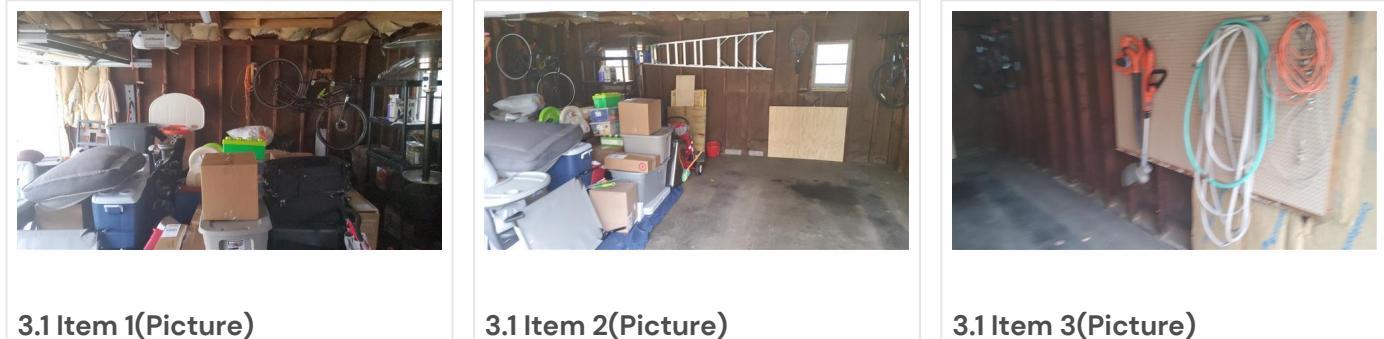
- INSPECTED
- (1) The garage walls are unfinished.

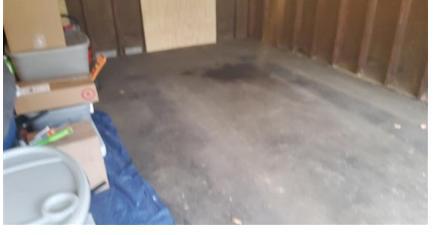
3.2 Item 1(Picture)

The garage floor is asphalt with settlement and heaving through out. The floor covers the sides of the sill plate and is not sloped in a specific fashion to the promote water drainage out in overhead doors. This increases the risk of water damage/deterioration of the wall structure. Removal and replacement with a properly draining floor is recommended.

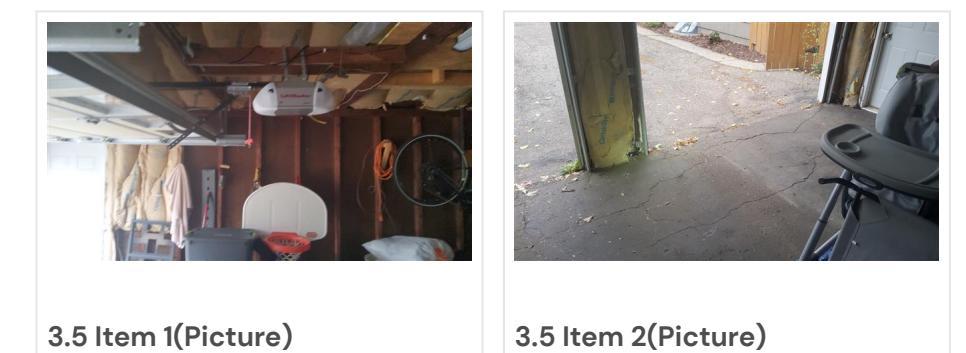
- ✓ INSPECTED
- 3.5 GARAGE DOOR OPERATORS (REPORT WHETHER OR NOT DOORS WILL REVERSE WHEN MET WITH RESISTANCE)
  - 🗂 INSPECTED
  - (1) The sensors are in place for garage door and will reverse the door.

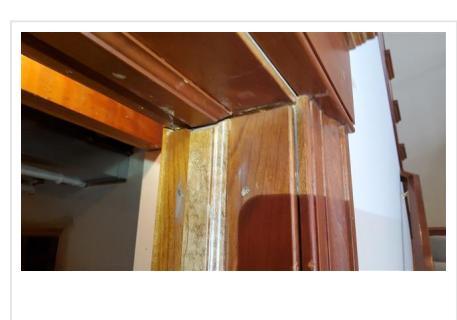
4.5 Item 1(Picture)

- 📋 INSPECTED
- (1) There are 11 interior doors on the main level. All are in functional condition.
- (2) Basement mechanical room door. The strike side upper corner of the jamb is broken. Repair or replacement is recommended.

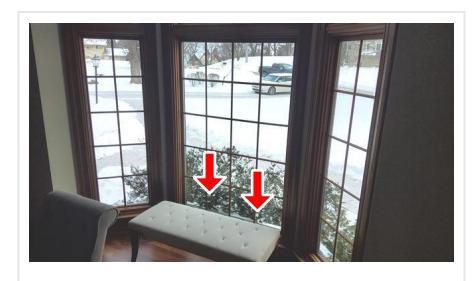
- 4.6 Item 15(Picture)
- (6) Center window in the dining room. The lower sash is rotten across the bottom rail. Replacement is recommended.

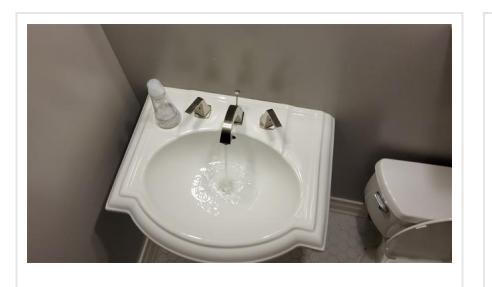
(4) Basement bathroom plumbing fixtures. I ran water through all of the fixtures for several minutes. There was no visible leaking or obstructed drainage during this process.

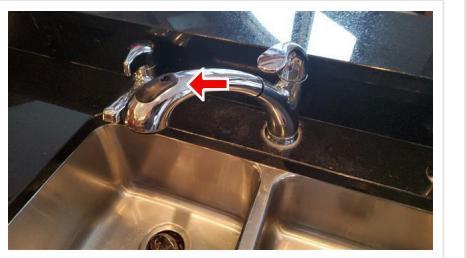
(5) Kitchen sink fixture. The rubber button at the spray head is worn thru. Repair or replacement is recommended.

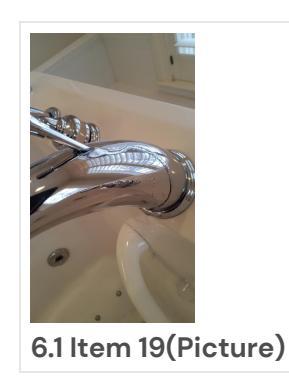
6.1 Item 18(Picture)

(7) Master bathroom plumbing fixtures. I ran water through all of the fixtures for several minutes. There leaking at the tub fixture, there was no further visible leaking or obstructed drainage during this process.

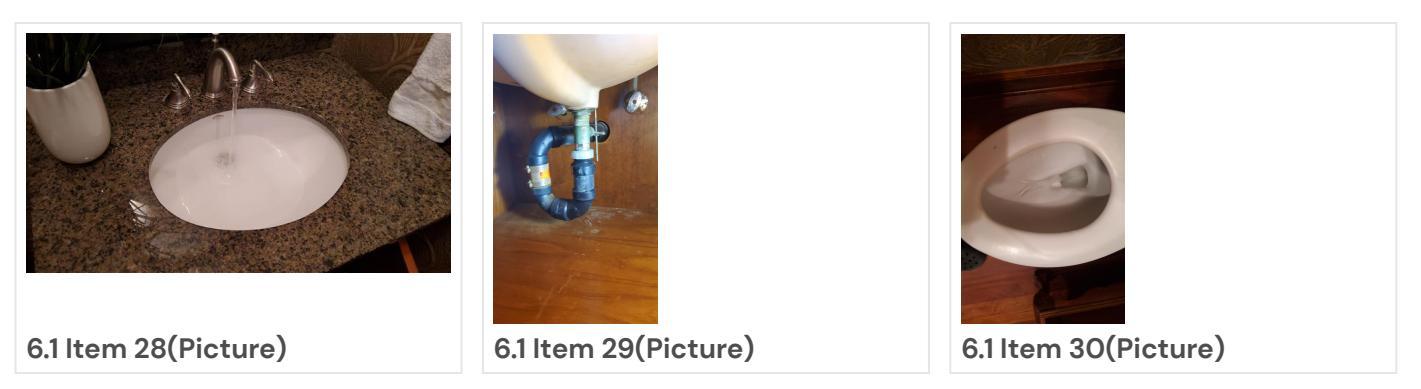
(8) Main level half bath plumbing fixtures. I ran water through both fixtures for several minutes. There was no visible leaking or obstructed drainage during this process.

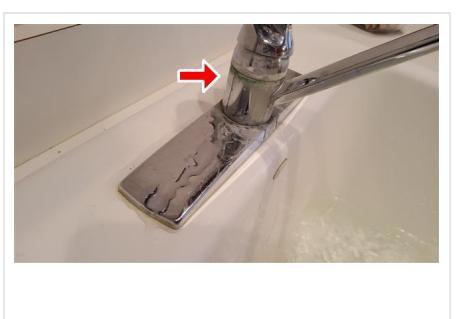
6.1 Item 34(Picture)

(10) Main level laundry room utility sink fixture is leaking. Repair or replacement is recommended.

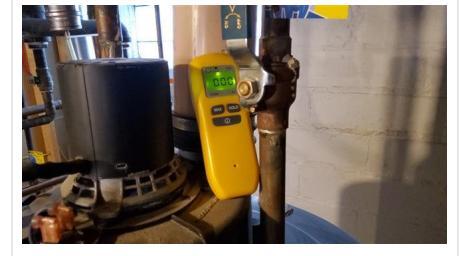
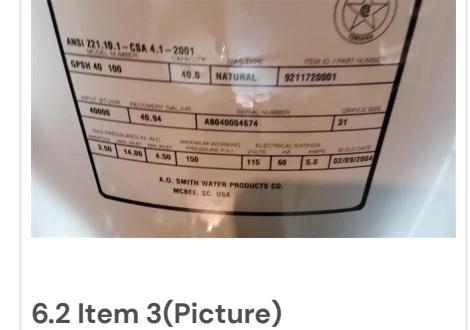
6.2 Item 1(Picture)

(1) The water heater was manufactured on 2/9/2004, the expected useful life of a water heater is 10-15 years. The water heater was quiet in operation with a CO reading near the flue during operation of 0 ppm. There was no visible leaking or corrosion around the unit.

Due to the age of the water heater, replacement should be anticipated in the near future.

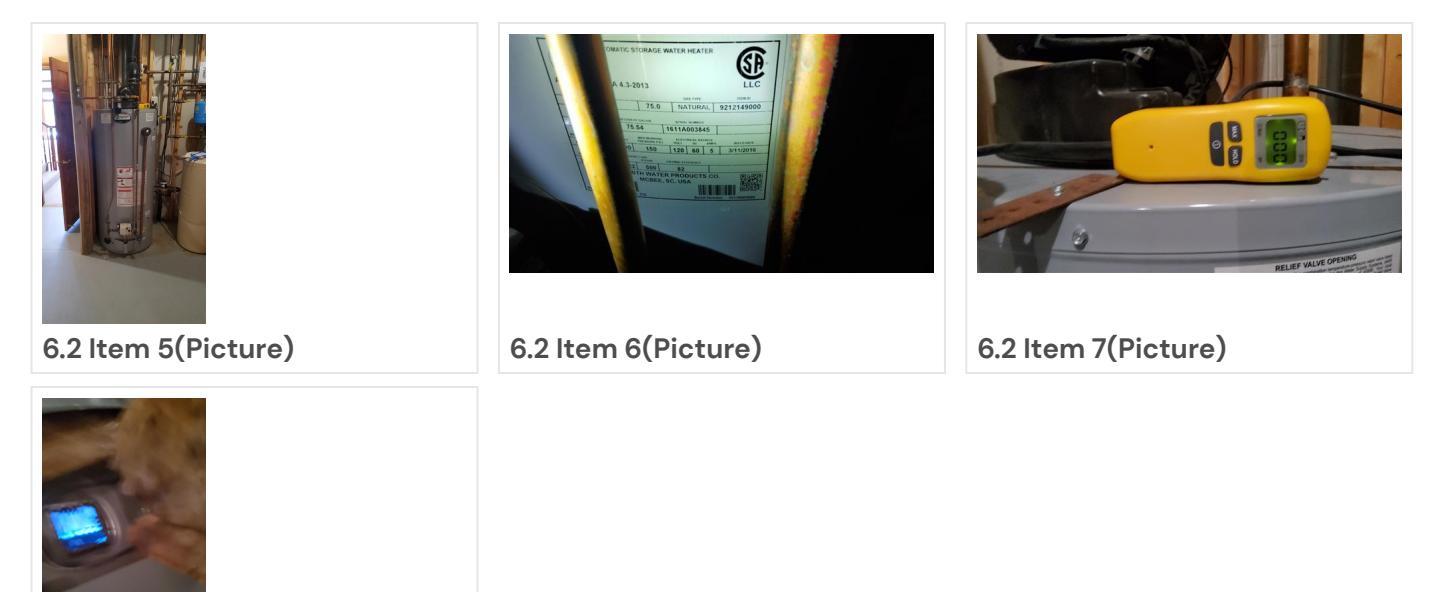
(2) The water heater was manufactured on March 11th 2016, the expected useful life of a water heater is 10–15 years. The water heater was quiet in operation with a CO reading near the flue during operation of O ppm. There was no visible leaking or corrosion around the unit.

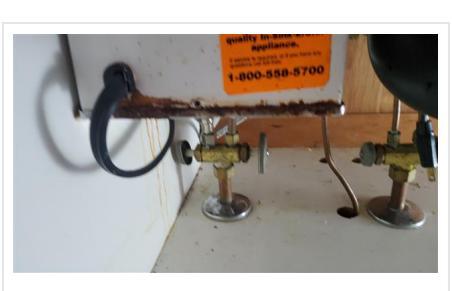
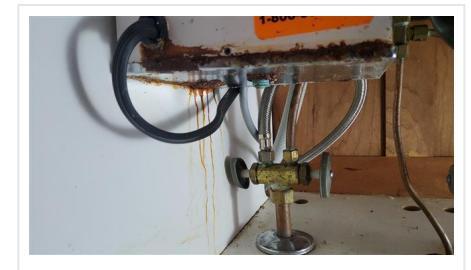
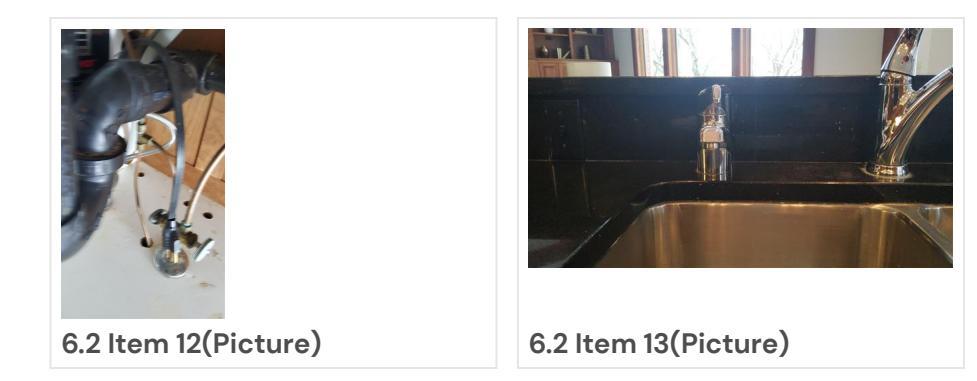
6.2 Item 9(Picture)

(3) The on demand water heater at the kitchen sink is currently unplugged and not in use. There is rust and evidence of leaking around the bottom of the unit. Replacement is recommended.

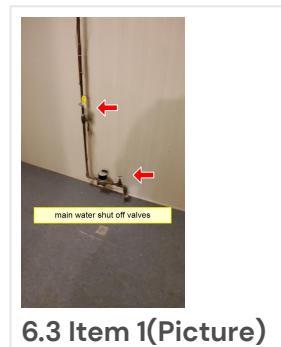
- ✓ INSPECTED
- (1) The water meter and main shut off valve is located at the W side of the home.

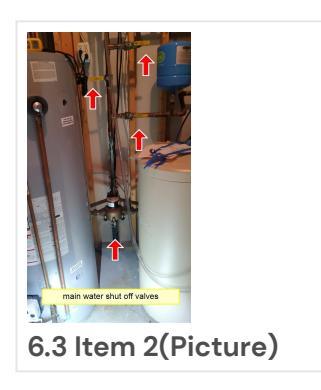
(2) The water meter and main shut off valve is located in the basement utility room.

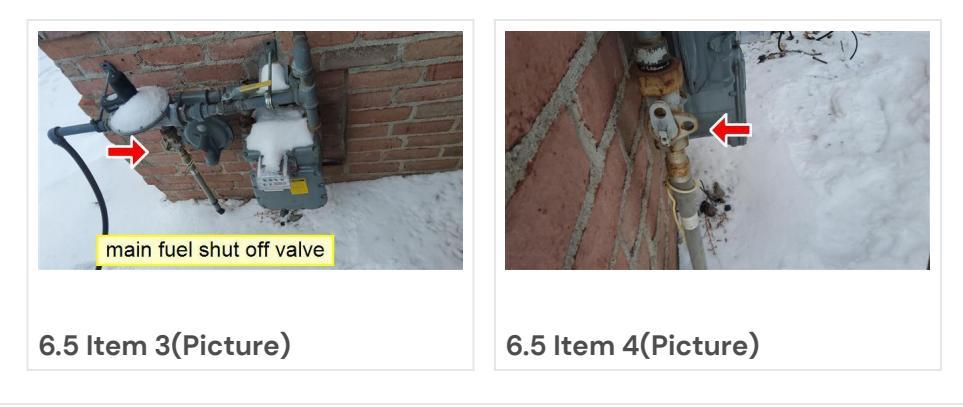
(2) The gas meter and main shut off valve is located at the S side of the home.

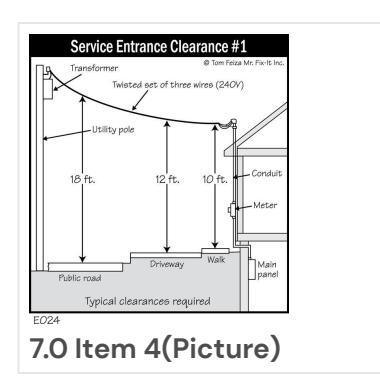
7.0 Item 3(Picture)

- TINSPECTED
- The electric meter and overhead power drop are located at the S side of the home. The power lines are less than 10 feet from the deck surface. This is a safety hazard. Raising of the lines by a qualified contractor to meet modern code is recommended.

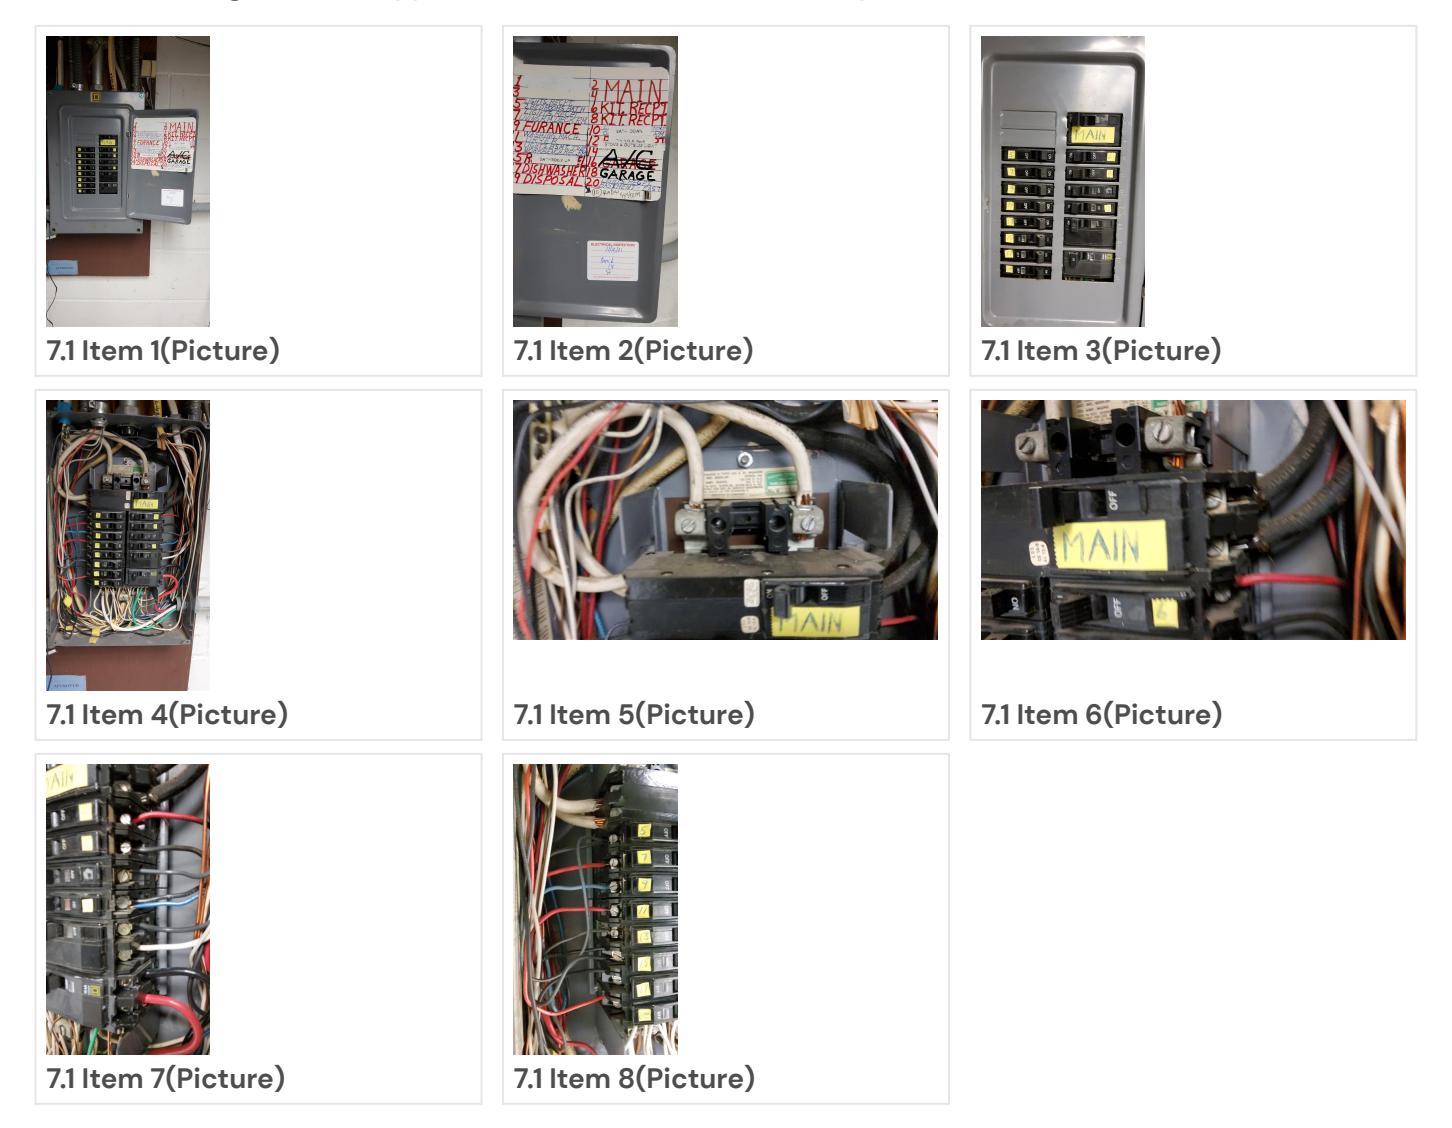
100 Amp Square D main electrical panel with circuit breakers. There was no visible evidence of overheating, corrosion or illegal double tapped breakers at the time of the inspection.

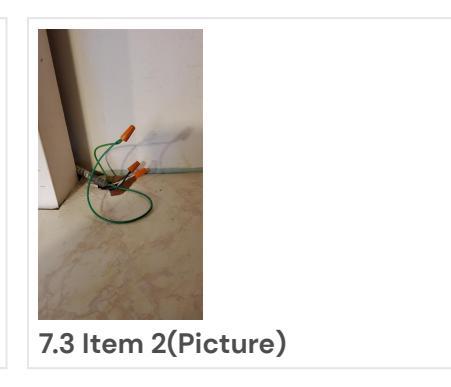
7.3 Item 1(Picture)

- ✓ INSPECTED
- 7.3 CONNECTED DEVICES AND FIXTURES (OBSERVED FROM A REPRESENTATIVE NUMBER OPERATION OF CEILING FANS, LIGHTING FIXTURES, SWITCHES AND RECEPTACLES LOCATED INSIDE THE HOUSE, GARAGE, AND ON THE DWELLING'S EXTERIOR WALLS)
  - 🗂 INSPECTED
- (1) There is an open electrical connection in the cabinet above the range. All electrical connections should be fully enclosed in a proper junction box. Repair by a qualified contractor is recommended.

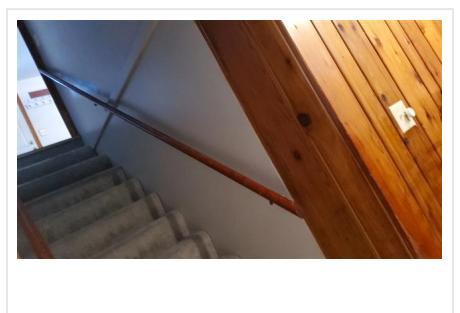
7.3 Item 3(Picture)

(2) The 3 way switch for the light at the bottom of the basement stairs is improperly wired. It only works when the switches are in specific settings. Repair by a qualified electrician is recommended.

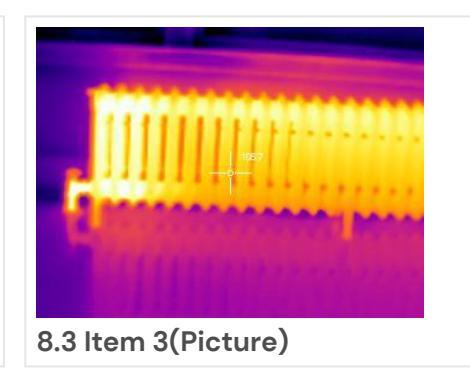
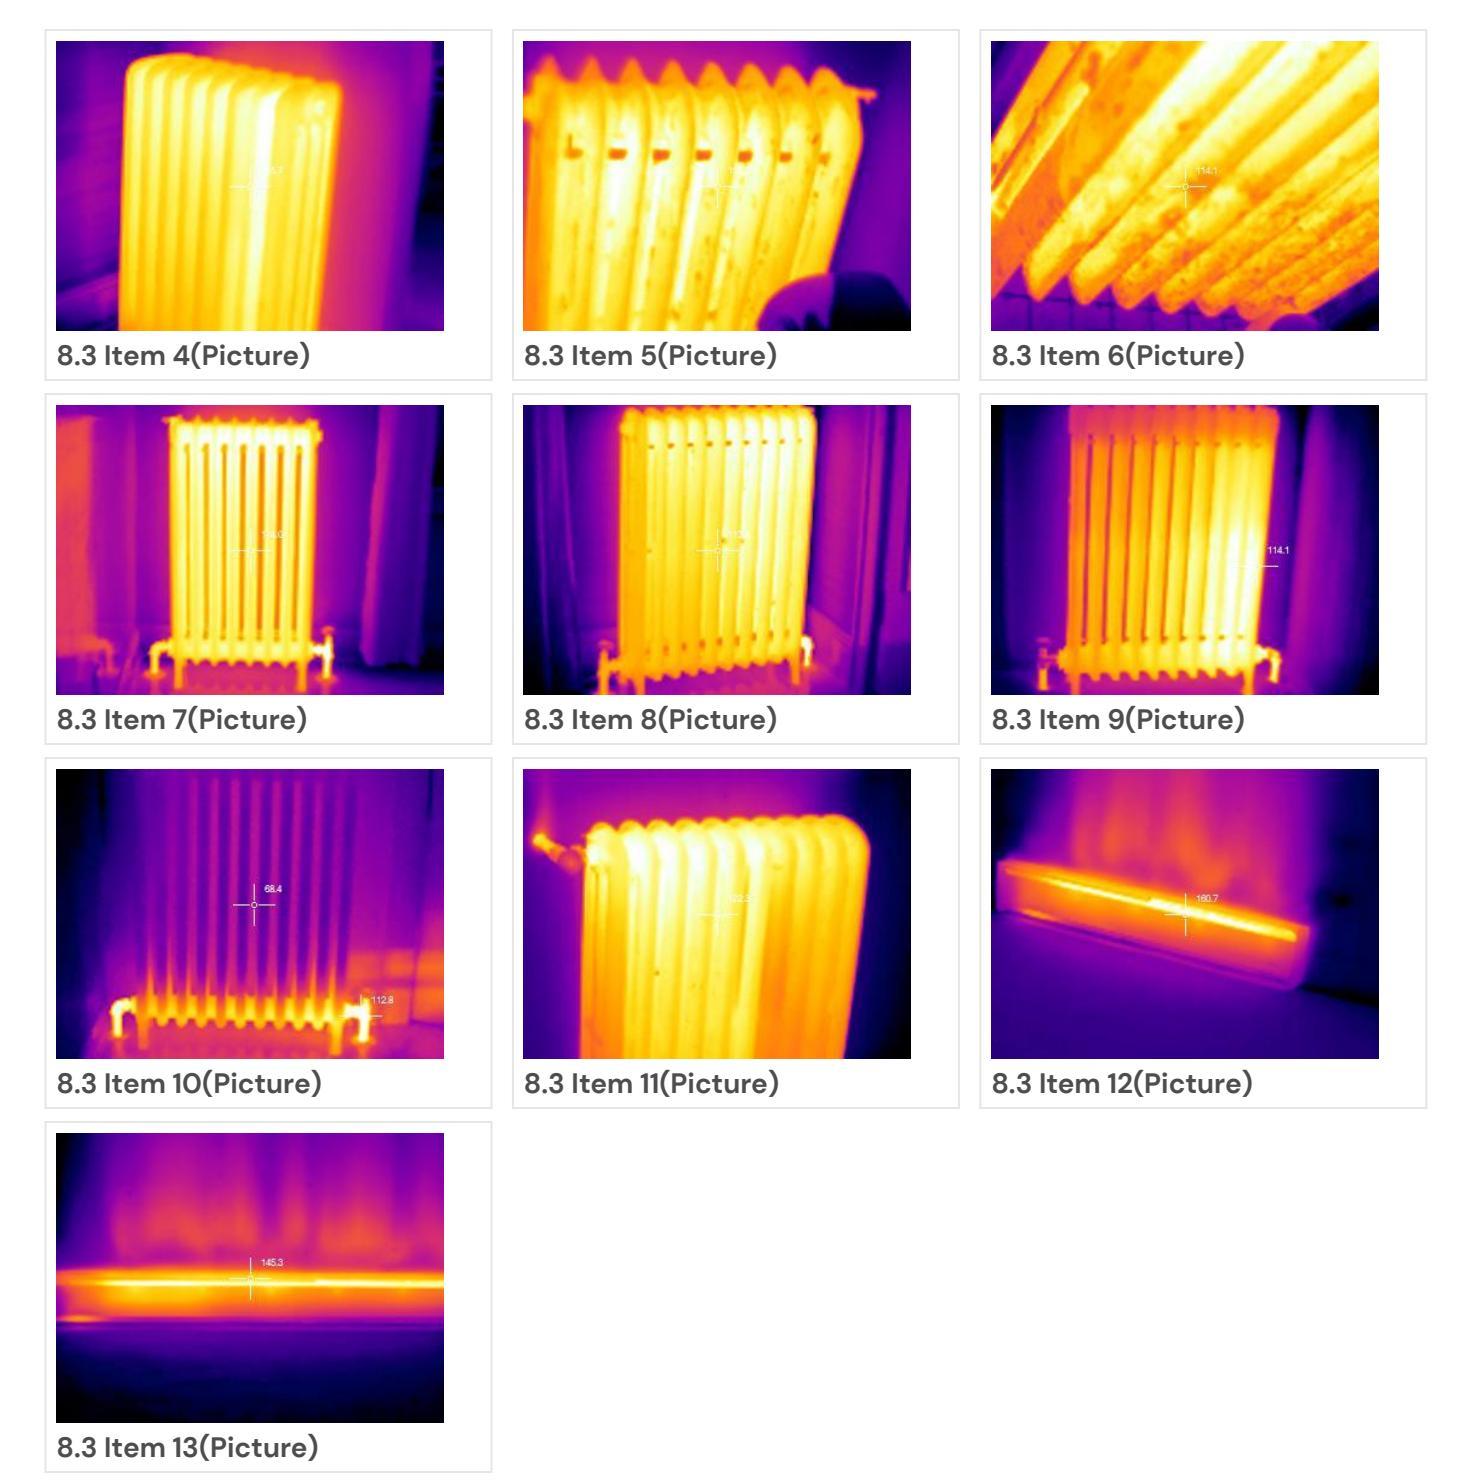
- INSPECTED
- (1) There are 12 radiators in the home. 1 is not heating properly the remaining are in functional condition.

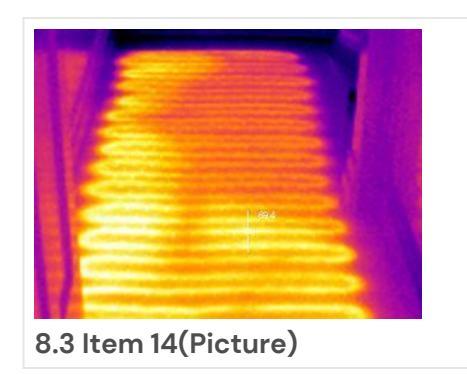
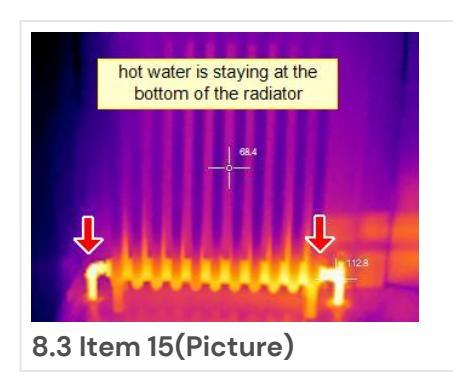
(2) In-floor heat at the basement bathroom is in functional condition.

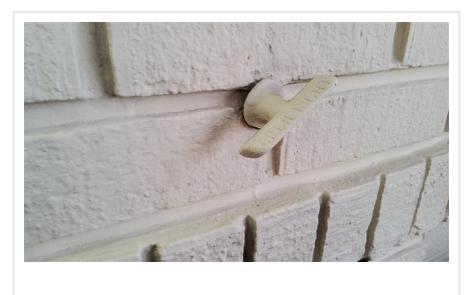
8.6 Item 1(Picture)

Main level family room wood burning fireplace. There is some cracking at the fire bricks and mortar. The flue damper operating mechanism is not working. Further assessment by a qualified chimney sweep is recommended. Repair or replace as deemed necessary.

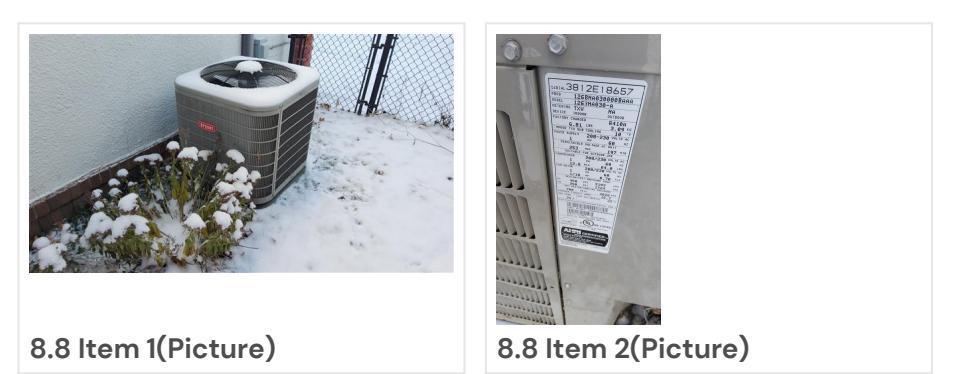
The AC compressor was manufactured in 2012, the expected useful life of a an AC system is 15–20 years. Due to low outside air temperature, below 60 degrees, I was unable to verify proper function of the AC system without risk of damage to the compressor.

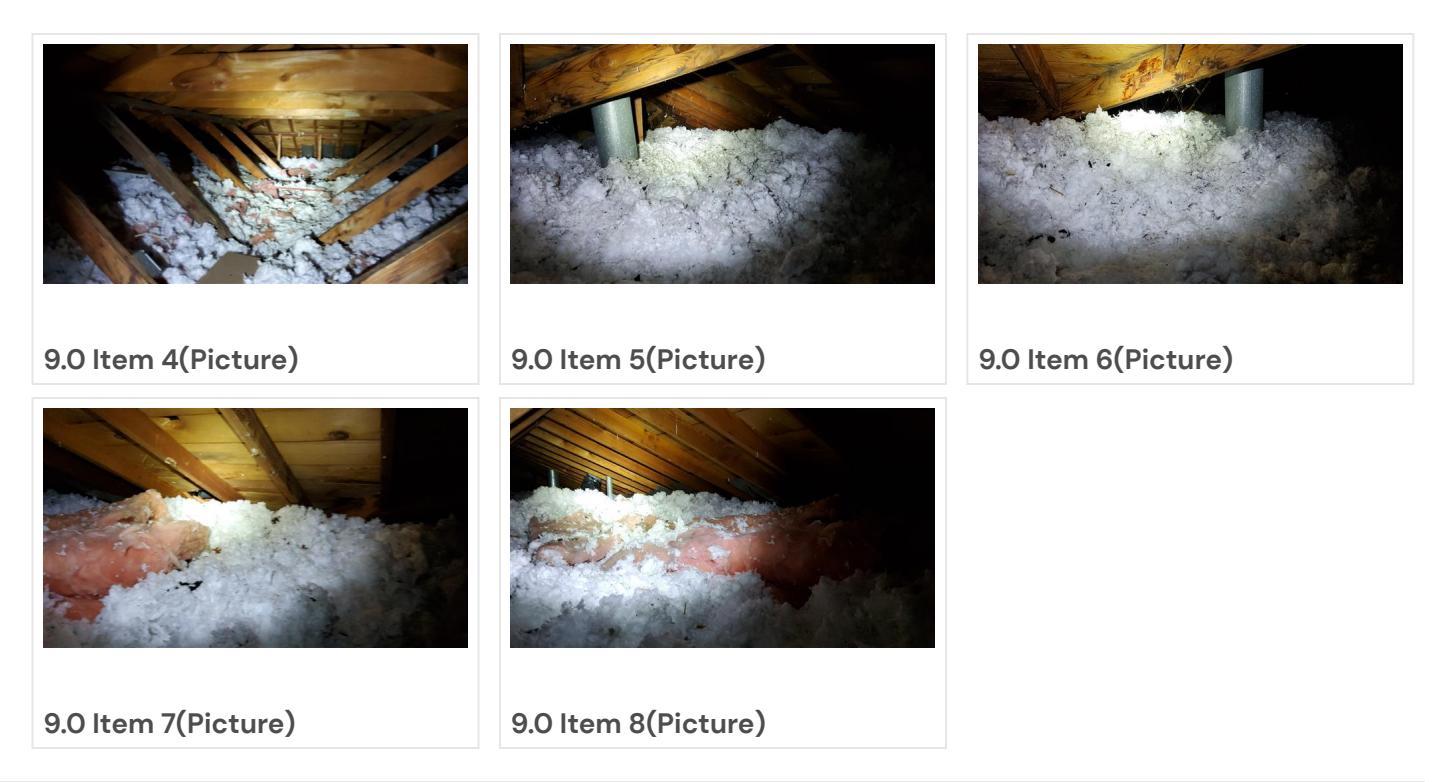
9.0 Item 3(Picture)

There is about 12–14 inches of blown fiberglass insulation at the attic. Modern standard is R49 or better, about 16–18 inches depending on the specific insulation used. Additional insulation is recommended for greater energy efficiency of the home.

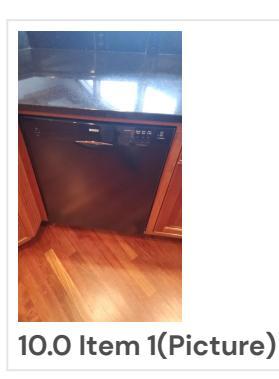
The dishwasher makes a loud vibrating sound when turned on. Repair or replacement is recommended.

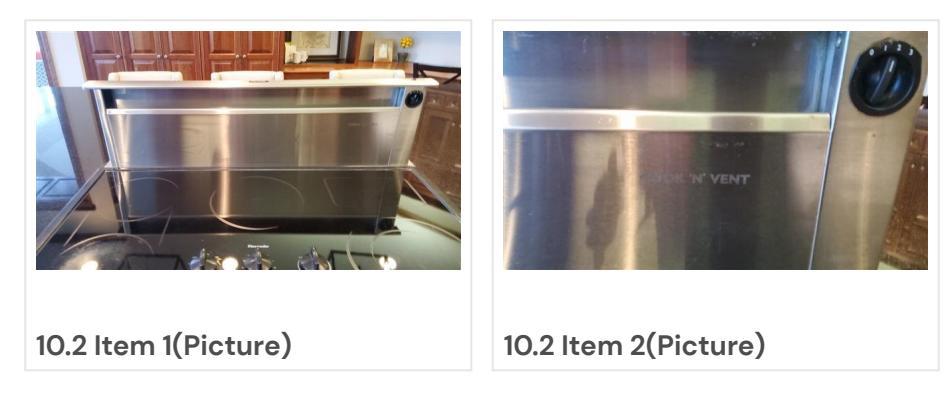
The downdraft vent at the back of the cooktop is in functional condition.

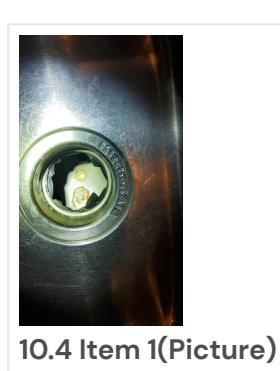
The shroud at the opening to the disposal is torn and mostly missing. The disposal is in otherwise functional condition. Replacement is recommended.

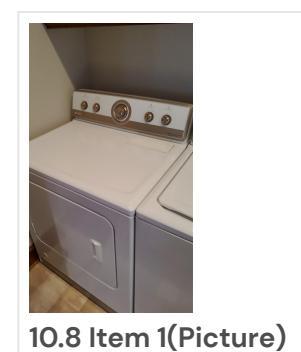
# **10.8 CLOTHES DRYER**

The clothes dryer was in functional condition at the time of the inspection
